# Retrofitting and Rehabilitation of damage footbridge over Yamuna River

Anjani Kumar Shukla, P R Maiti

**Abstract:** Every Structure has a certain predefined age with which it has to withstand, and after that, it requires the rehabilitation/repairing to avoid any damage or collapse. The footbridge over Yamuna River in Delhi, India was constructed in 1960 adjacent to Wazirabad barrage, and this is a very important link to East Delhi and West Delhi. Due to heavy traffic plying on this footbridge, in due course of time, the signs of deterioration were visible in the bridge expansion joint assemblies in the deck slab and cantilever portion of footpath slab. There were many potholes also developed in the wearing course. It was also dilapidation observed in many portions of the footpath, and some portion of the footpath slab were collapsed. The cantilever portion of the footbridge was retrofitted with steel jacketing fixing in the main longitudinal girder of the bridge. In this study analysis of the cantilever footbridge slab retrofitted by a steel jacket was carried out to check the deflection and stress limit of the bridge and it is found that the bridge is safe and now Bridge is op

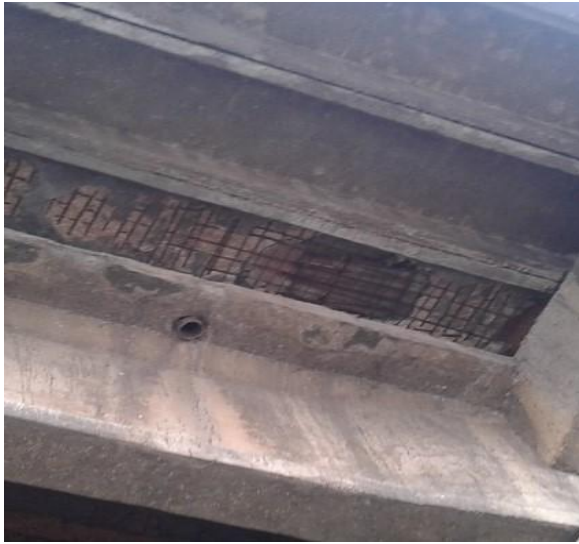
The concrete mix M25 were used in the Slab and M15 in the handrails bottom as recommended by the IRC 5: 1956. The strength of concrete mix M25 was 25.3 MPa and 16.8 MPa for M15. A layer of waterproof concrete was applied on the bridge deck pavement whose strength was 22 MPa. For wearing coarse Asphalt Concrete was used. By improving construction technology and adding admixture in the mix proportion of concrete an impermeable waterproof concrete was prepared. A steel crush barrier of 4-meter height was installed to avoid type of accident due to river. Time by time development on both side of bridge increases in the result of heavy pedestrian load including heavy motorcycle and 3 tyre small public transport. Also the day by day decreasing the water quality at Okhla Barrage was also a reason for damaging the foot bridge. The foot bridge was damaged brutally years ago and become unserviceable because of that intensity of overloaded pedestrian and vehicle could not present in this study. Damage to the foot bridge such as deteriorated Joints, cracking in the concrete, steel corrosion, scrapping of the outer layer of concrete were noticed before demolition. Figure 3 to Figure 6 shows the foot bridge damage.

**Figure 3 Bottom View of footbridge slab**

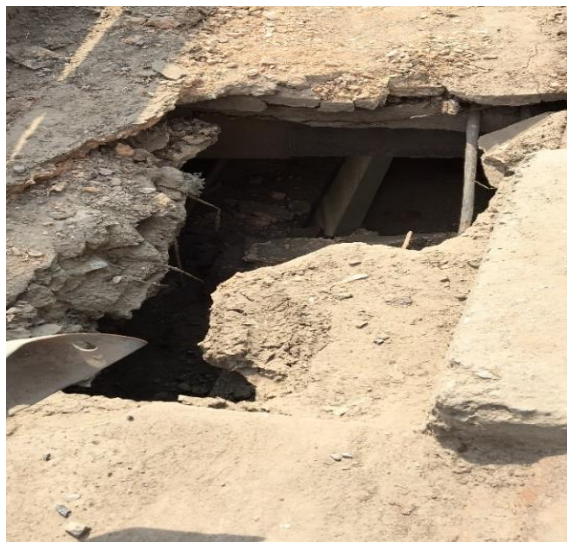
As damage to the footbridge slab can be seen in the Figure 4. The covering concrete had been scrapped at some extent and reinforcement also deteriorated due to salinity of water. So it was needed to replace urgently. Surface of footbridge also got damage due to excess loading can be seen in figure 4 as it become unserviceable. Figure 6 shows the brutally damage of reinforcement and footbridge slab due to salinity of water.

**Figure 4 Top View of Slab**

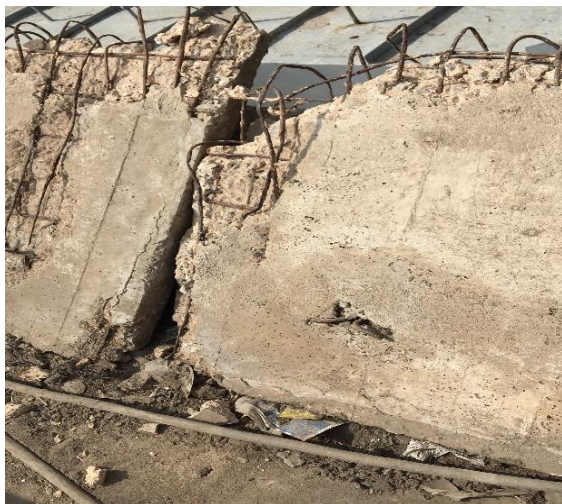
The footbridge has been damaged and become unserviceable (Figure 3 & Figure 4) due to overloading, material aging and salinity of water. The slab of footway was damaged at the extent from where repairing was not possible. The footbridge has been scrapped completely (Figure 5). After scrapping the damaged footbridge portion the rehabilitation of cantilever beam has been done by jacketing with steel. After jacketing the cantilever beam, the fabrication of deck slab was done by PPGI sheet as permanent shuttering and a fresh deck slab laid down (Figure 14).

**Figure 5 Scrapped portion of deck Slab**

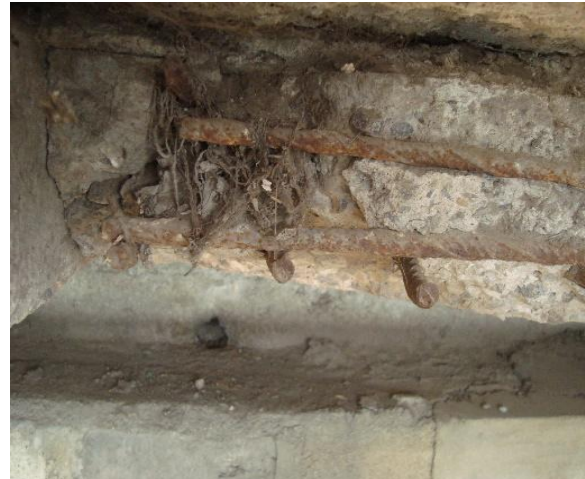
**Figure 6 Deteriorated Reinforcement of slab**

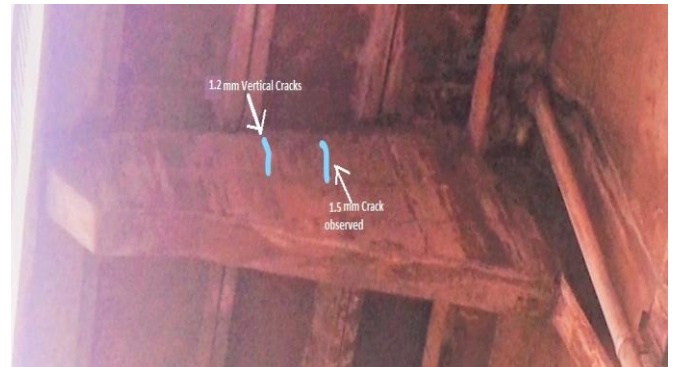
In the Figure 7 the cracks forms due to the Excess Loading and Aging can be easily seen. The several crack which is exceeding the standard limit can be easily observed.

**Figure 7 Crack observed in the beam supported slab**

There were many factors because of which cantilever beam deteriorated and crack can be easily seen in Figure 7. Like Aging, Water flowing below footbridge contains  $SO_4$  and  $CL^-$ , Increased Traffic density. In this work the Steel Jacketing in both side of cantilever beam has been done Figure 8. The Modelling was done using the STAAD Pro. V8i (Figure 9).

As some cracks were observed in the cantilever beam supported to slab (figure 7) and slab of foot bridge was also damaged by water quality flowing below so to prevent in future a preventive layer of PPGI sheet also provided Figure 10 and 11. The Retrofitting of the existing footbridge slab was not possible without scrapping entire footbridge slab. So first entire slab was needed to scrap carefully. The IRC 6 suggested that if the crack in the cantilever beam is greater than 1mm under service load then it need to be strengthen immediately so to strengthen the cantilever beam steel jacketing of ISMB angles and plates section has been used (Figure 5 & Figure 6). The details are given below-

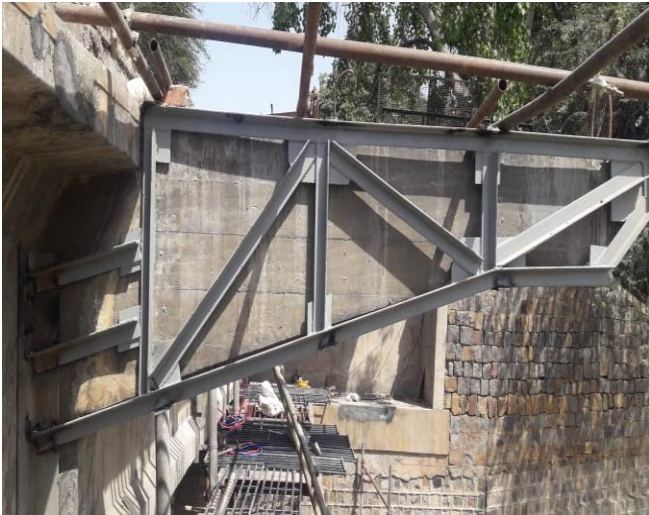
Figure 8. Jacketing of Cantilever beam of footbridge

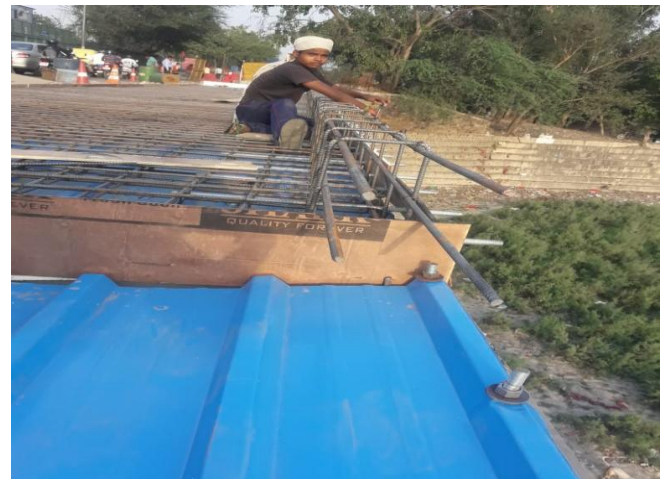
Figure 10 Laying of PPGI sheets

As specified in table 2, PPGI sheet were drawn below the deck slab to protect the Deck slab from the corrosion and deterioration from dangerous chemical in below flowing river Figure 10 and Figure 11. The sectional line diagram of deck slab can be observed in Figure 12.

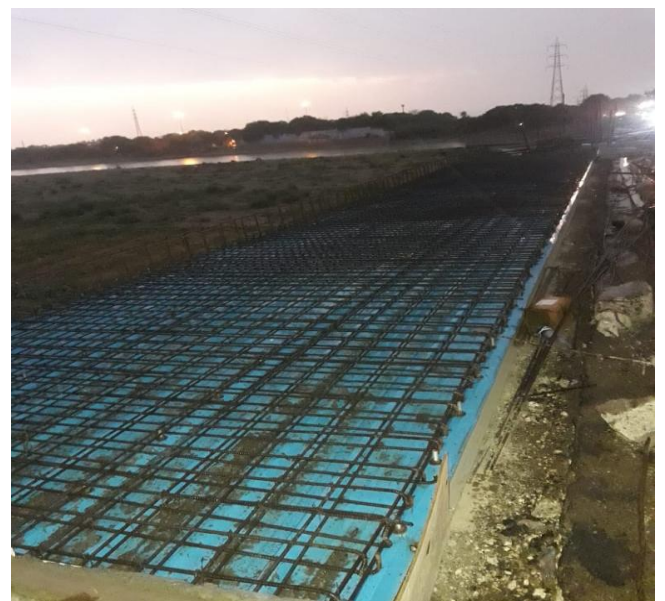
Figure 11 Skelton of steel for Deck slab

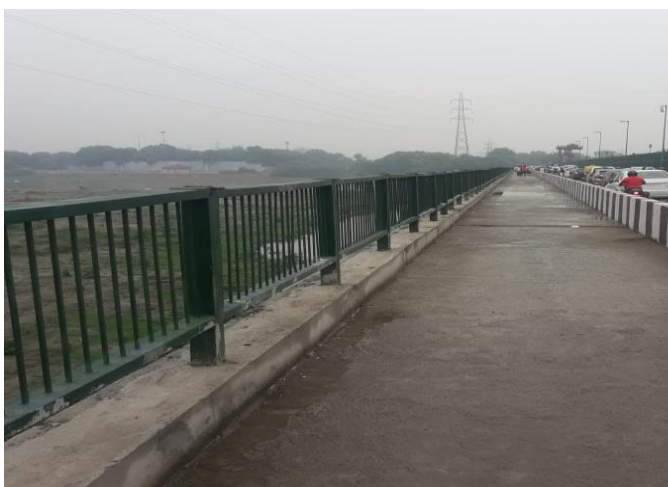
Figure 14 Final View of Retrofitted foot bridge Slab

1. The Maximum Resultant Displacement is 9.526 mm, which is in downward side.
2. The Maximum Horizontal Displacement in X direction is 4.957 mm.
3. The Maximum Axial Compressive Stress is -9.227 N/mm<sup>2</sup> in both steel beam which is fix with main girder of bridge and between node 22-26 and 3-10.
4. The Maximum Axial Tensile Stress is 21.824 N/mm<sup>2</sup> in Both steel beam which is fix with main girder of bridge and between Node 17-28 and 12-14.
5. Retrofitted footbridge were open for the traffic (Figure 14) when analysis steel jacketing members and found all safe.
