Chapter: 3

Study Area

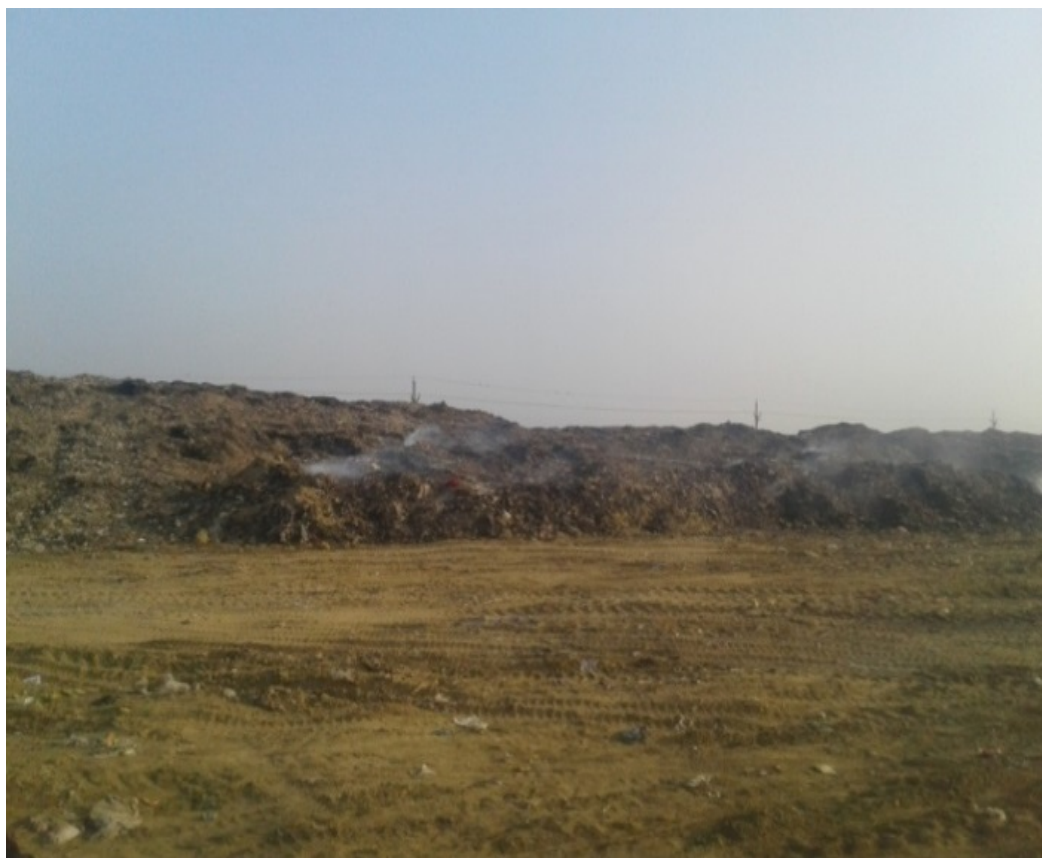
Figure 3.2 Municipal solid waste dumping sites in Ramna village.

The RamnaMSW dumping area is located at approximately 2.64 kilometres in the west of the river Ganga and is surrounded by agricultural fields and residential area. This dumping site witnessed the fire the outburst in November 2014 affecting the environment of Ramna and other neighboring villages. The villagers had frequently complained against dumping of waste in the site and demanded for its immediate closure. Yet there is no proper action taken by municipal and district authorities to

mitigate its impact on surrounding environment especially air and water quality. The dumping site at Ramna is a temporary arrangement after solid waste management plant at Karsara was closed due to a dispute between the Varanasi Municipal Corporation and the company engaged for waste collection and disposal. Municipal Solid Wastes (Management and Handling) Rules, 2000 [13] states that the landfill site should be away from residence clusters, but opposing to the rule the dumping sites are surrounded by several villages including Ramna, Dafi, and Seer. According to the rule, wastes subjected to landfilling should be compacted in thin layers using landfill compactors to attain a high density of the wastes and it should be covered immediately or construction material until waste processing facilities for composting. But, no such provisions have been made here(Times of India, 2016).

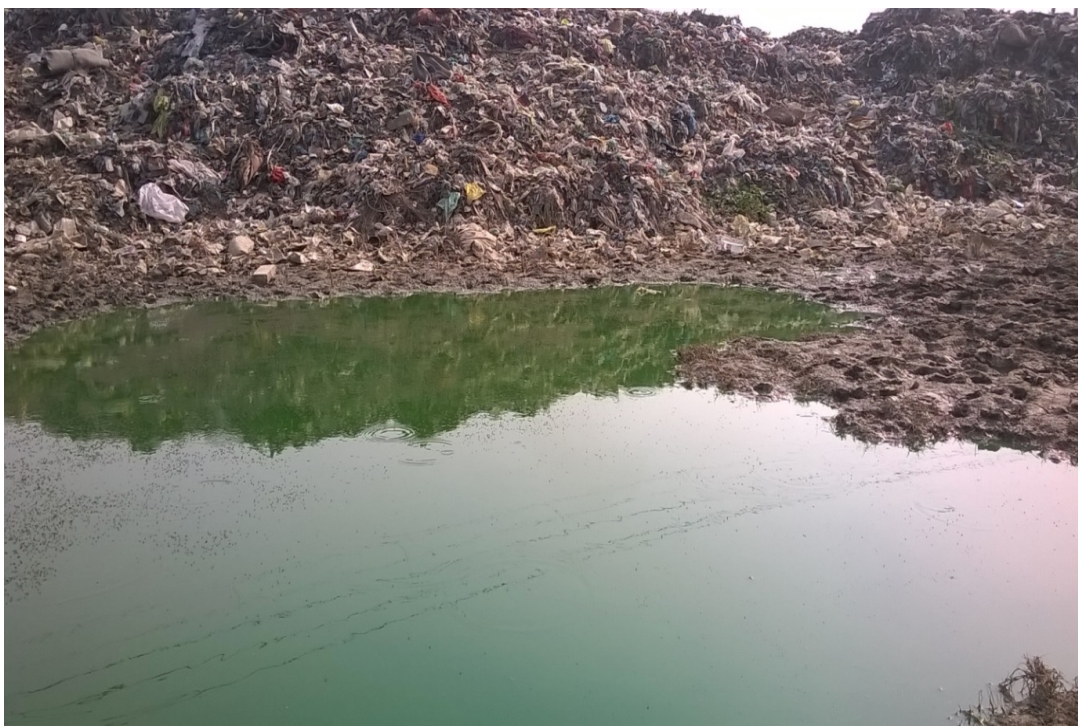
Figure3.3 Ramna MSW Leachate.

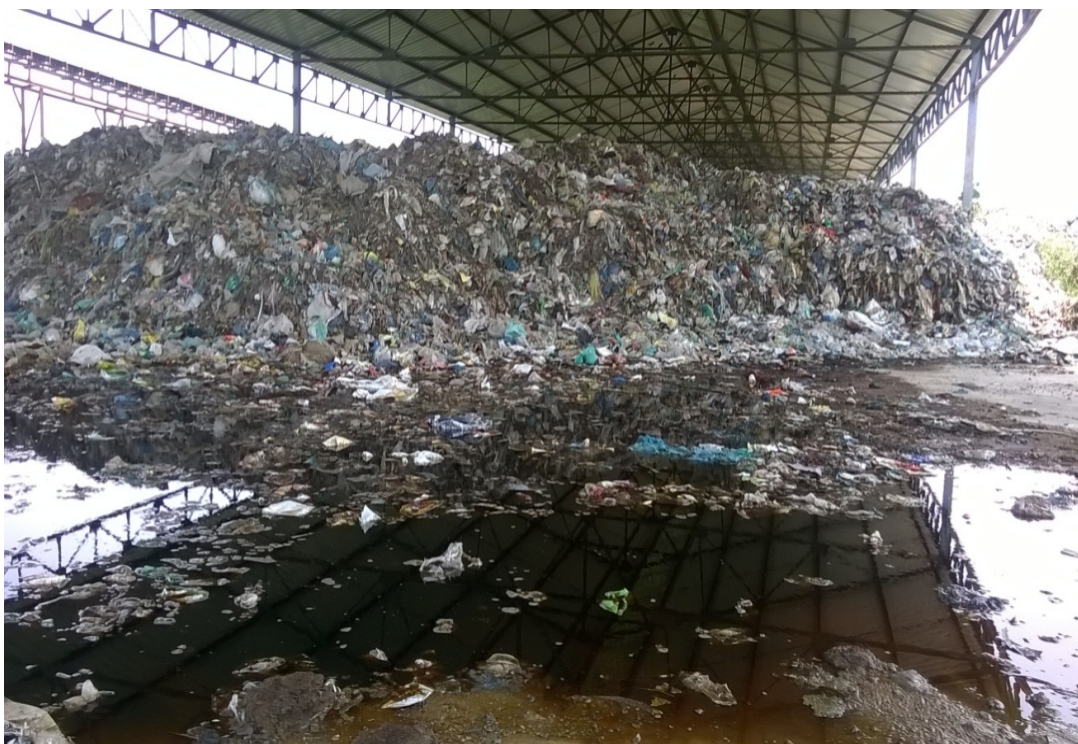
Figure 3.4 Karsara MSW leachate.

The Karsaradumping site was selected for present study, located between 25° 12' 50.88" N latitude to 82° 55' 6.75" E longitude in Varanasi City, Uttar Pradesh, India. It is non-engineered without having any base liner leachate collection system, situated in the low-lying dump area and covering a 6 km² area, which is 80.7 m above mean sea level. Karsara dumping site has been inactive between 2012 to 2017 year. The dumping site is located at approximately 738 m north of the river Ganga (Figure 3.1) and mostly surrounded by agricultural fields and settlements. The climate of the study area is humid subtropical with high and severe cold (8.4 to 15.0 °C) during the winter seasons temperatures (38.5 to 41.2 °C) during the winter seasons.
