CHAPTER 4

ANALYSIS AND STRENGTHENING OF VEHICLE BRIDGE GIRDER AT PUSA : A CASE STUDY

4.2 Background of Pusa Bridge

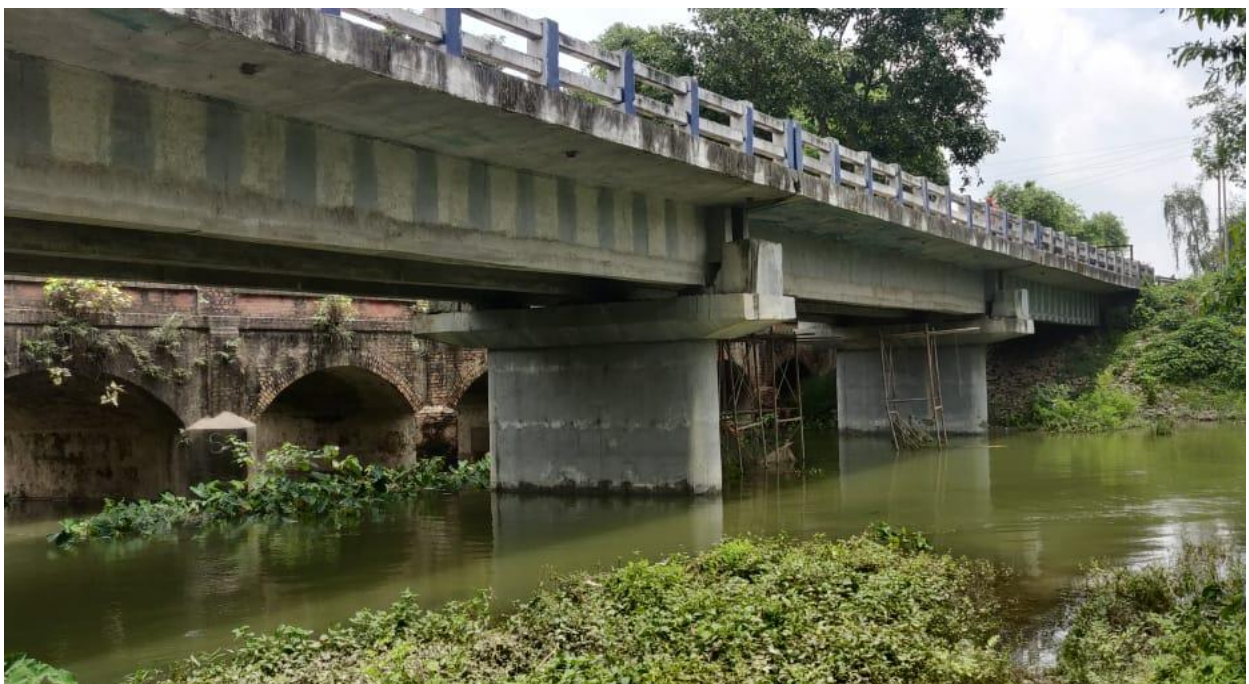
Figure 4. 1 View of Pusa-Muzaffarpur bridge

This bridge connects Pusa and Muzaffarpur in Bihar, India. two-Lane bridge at Pusa Muzaffarpur road is a simply supported R.C. bridge and has three concrete girders with a reinforced concrete deck slab. It is situated at Pusa mile stone 26 K.M. Dist- Muzaffarpur, Bihar. The bridge's substructure consists of simple R.C. piers, abutment, and the type of foundation is a pile foundation. (Figure 4.1 and Figure 4.2). The length of the girder is 16.5 meter and the bridge has the pile type foundation and 3 numbers of R.C. girders with R.C. deck Slab. The total length of the bridge is about 70 m, and the bridge belongs to seismic zone IV. With the time the intensity of traffic increased on the bridge and load increased on the girder. The environmental effect and age of the bridge also a key factor in the deterioration of the bridge. An inspection was performed on this Pusa bridge to estimate the profundity of the dilapidation.

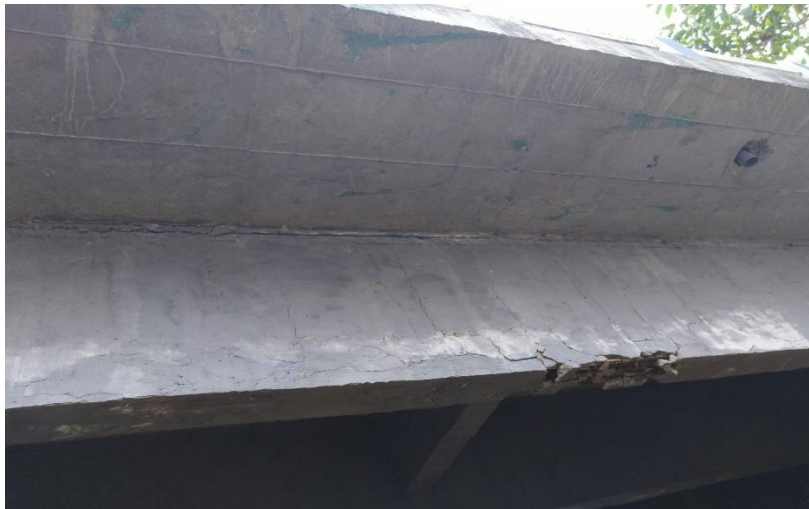
Figure 4. 3 Wide flexural cracks in the full depth of RC girder

There was excessive deflection noticed in span no.1 and 4 which resulted to reduced flexural strength of girders as these were found severely distressed. It is clear from the visuals on site that the cover is about to get separated in a larger length. This indicates that the cover's delamination has already been started or has tendency to start in the future. It must happen because there are voids between reinforcing bars, which can be noticed where the cover has already been separated,

1. The superstructure was found in a very distressed condition. There were various wide cracks found at multiple locations in span No. 1 and 4. These cracks were very severe, wide and active and very detrimental for the bridge's structural strength and safety. (Figure 4.3)
2. The concrete cover was found delaminated at multiple locations as shown in Figure 4.4. The reinforcements were poorly exposed due to delamination of concrete cover. It was found that there was no concrete present between reinforcing bars. The section was almost hollow at several locations at the bottom due to the presence of voids between reinforcing bars. This must-have resulted as adequate compaction of concrete between crowded reinforcing bars might not have ensured at the time of construction.

Following are the conclusion and recommendations based on the analysis of the girder using FEM. Composite fibre of carbon fibre reinforced polymer, (CFRP) in shear zone and glass fibre reinforced polymer (GFRP) in tension zone for R.C. girder should be used for strengthening. Flexural and shear capacity can be enhanced by using this state-of-art. Since the section has lost its strength in flexure and shear. The strength of R.C. girders in flexure can be improved by providing carbon fibre laminates at the bottom face of bottom flange and shear strength can be enhanced by applying glass fibre sheet at side of beam. Hence the cover should be intact with the structure so all loose cover should be removed and reinforcement lied in this area should be make visible and appropriately cleaned with anti-corrosive paint. New cover should be provided by applying micro concrete. The voids should be filled with non-shrinkable cement grouts with pressure grouting by sealing all cracks at concrete surface. All wide cracks should be repaired by cement grout. Fine cracks can be repaired by doing epoxy grout.

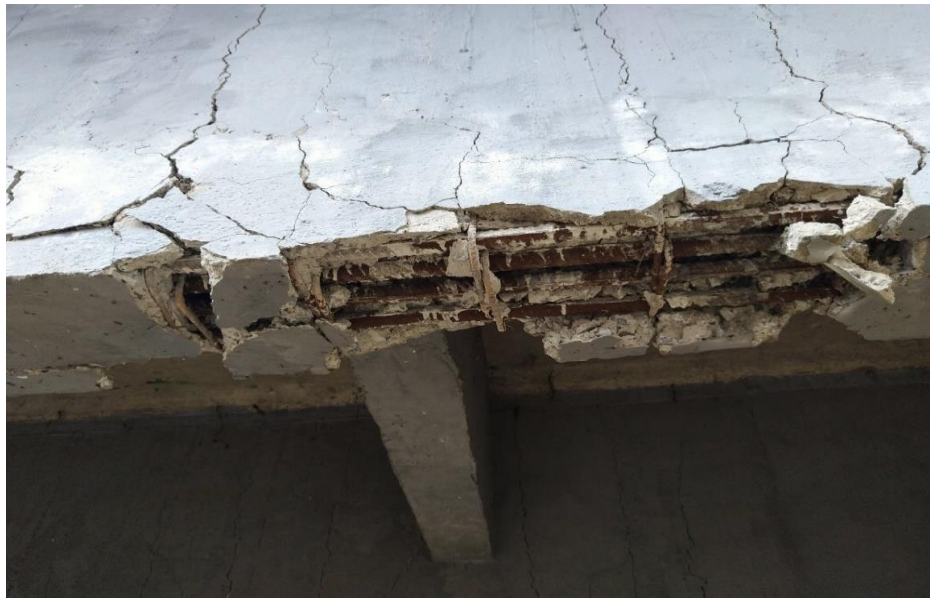
Figure 4. 5 Exposed reinforcement of girder with shear and flexure cracks

3. The reinforcing bars were found exposed at several locations as shown in Figure 4.5. The reinforcement was also found corroded.
4. The overall condition of concrete was terrible. The flexural cracks were extensive and present in the girder's full depth, indicating that the girder has wholly lost its flexural strength. There were wide shear cracks also. The concrete was found badly damaged and some parts are just hanging with the girders and about to fall.
5. Reinforced Concrete longitudinal girders' overall conditions are appalling; they are in severely distressed condition having numerous wide cracks originating from the bottom and going up to the top of girders.
6. The neoprene bearing has been used in the bearing which seems depressed very brutally due to unsymmetrical load distribution by girder. (Figure 4.6)

1. All loose concrete including loose covers were removed from the bottom flange. The cover below reinforcement was checked for hollowness and removed as there had already been delamination occurred inside the concrete. The reinforcement was adequately exposed and cleaned with rust remover. Anti-corrosive paint was applied. Bonding agents over old concrete was applied for better bonding between new and old concrete.

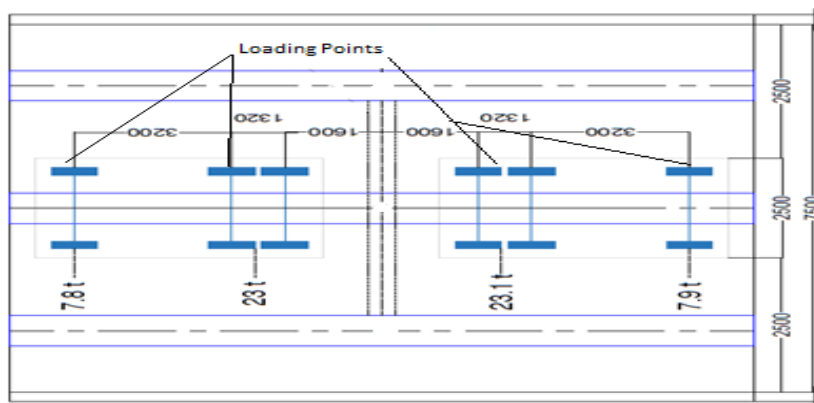
Figure 4. 7 Loading scheme of the deck slab

The T beam girder consists of 3 T beams of effective span 16.5m each spaced at 2.5 m c/c from each other. The girder supports a two lane road and has been loaded in both the lanes

symmetrically with six axles of 7.8t, 11.5t, 11.5t, 11.55t, 11.55t 7.9 t on one lane. The contact area of tires with the girder surface has been considered according to IRC 6: 2016, Class A loading as 250mm X 500mm for 11.5t and 11.55t axles, and 200mm X 380mm for 7.8t and 7.9t axles (Figure 4.7 and Figure 4.8). The self-weight of the girder has also been considered by applying standard earth gravity in the ANSYS environment. The pavement weight has been applied as a pressure load of intensity 1875 Pa (considering unit weight of the pavement as 25kNm^{-3}), distributed on the top surface of the girder.

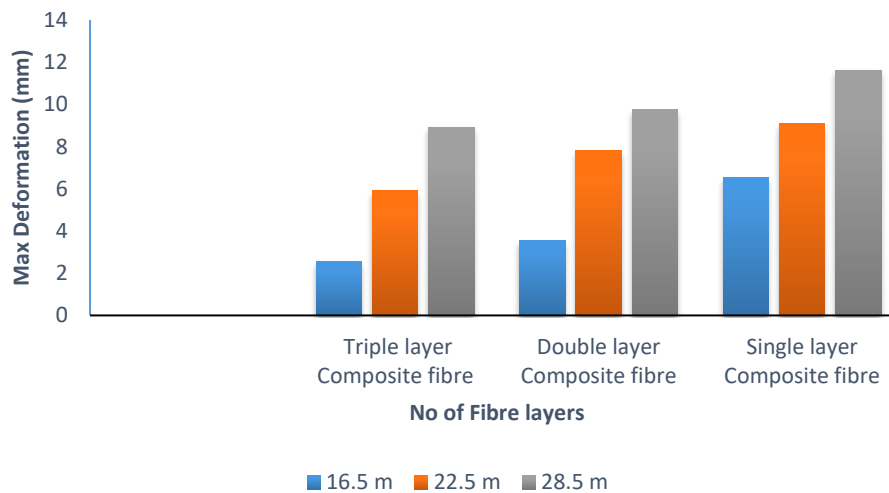
Figure 4. 11 Max deformation vs fibre layer for varying length of girder

Figure 4.11 described the contribution of GFRP and CFRP when they swathe more than a layer on a girder of varying length. The bridge girder of size 28.5 meter showed at least double recovery in the term of deflection when the layer of the composite was tripled while the

The deformation due to live load has been displayed after finite element analysis of girder for different IRC loads. Few apparent changes have observed when the layers of composite fibre were increased. In figure 4.11 it is clearly visible that for the longest span of bridge i.e. 28.5 m,

the deformation was vastly reduced when the layer of composite fibres CFRP and GFRP were tripled. In the case 1 when the length of the girder was 16.5 meter and the single layer of composite fibre were glued then the deformation in the girder was noticed 6.55 mm while this layer increased by one more layer then the deformation was found 3.54 mm and in the case of triple layer it decreased and reached to 2.53 mm. In the case 2 when the length of girder was 22.5 meter, the deformation in the single layer fibre 9.08 mm, in the double layered fibre it was 7.8 mm and in the triple layered fibre it came 8.75mm this time .

In the case 3 when the length of the girder was 28.5 meter, then in the single layer composite fibre the deformation was 11.63 mm, as soon as the layer of fibres were doubled the deformation was decreased and reached upto 9.74 mm and in the next case when the layers of fibres were tripled the deformation was reduced upto 8.92 mm.

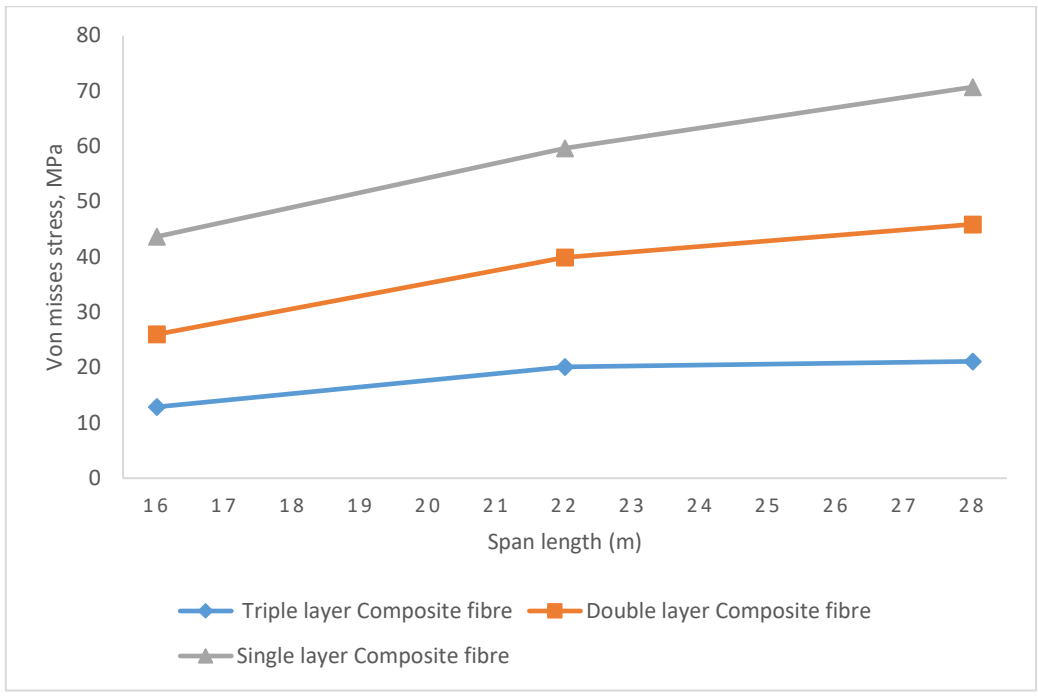
Figure 4.13 Max Von Mises stress vs span length for different fibre layer combination

Figure 4.13 the von-Mises stress of any structure describe its ability of yielding before discomfiture. The figure 4.13 consist the behaviour of composite laminated girders. The stress in single layered laminated girder the von Mises stress was found 24.8 MPa for the longest span which was 28.5m. Respectively for double and triple layer it was 24.77 MPa and 12.06 MPa. For shorter span length i.e. 22.5m and 16.5m the von Mises stress was reported 19.82 MPa and 13.66 MPa when girder was double coated by composite fibre and 20.10 MPa and 12.88 MPa for triple lode composite layer.

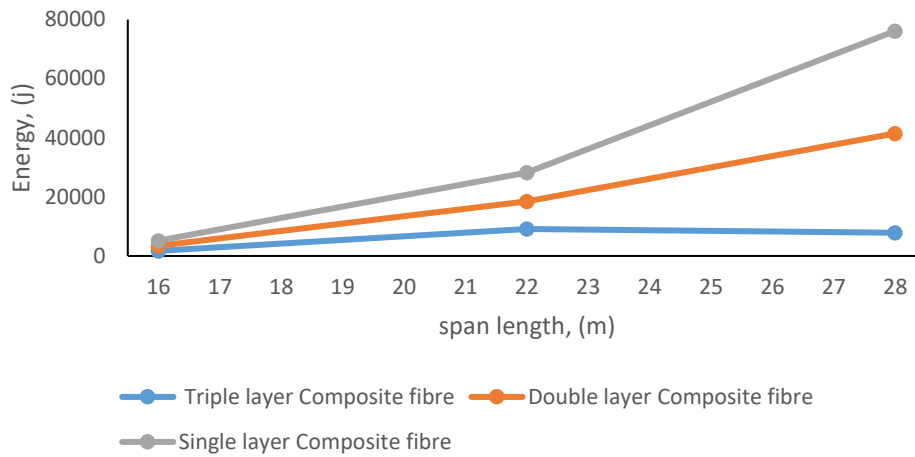
Figure 4. 15 Strain Energy vs span length for different fibre layer combination

Figure 4.15 explains the effect of layer variation of fibre on the different size of girder. The single layer composite fibre produces the 34654.8 Joule strain energy for 28.5 meter girder. After doubling the composite layer strain energy comes to 33633.14 Joule and in the case of triple-layer fibre the strain energy was found 7846.14 Joule. In the 22.5m and 16.5 meter long spans the strain energy reported 9342.54 joule and 1730.1 joule when doubling the both carbon and glass fibre wrapping. Figure 4.16 explains about the case where only carbon fibre used for retrofitting the girder. In this analysis the strain energy in the unstrengthened beam was found 33388.24 Joule and decreasing gingerly when the layer of fibres was single, doubled and tripled. In the case of single-layer carbon wrapping the strain energy in 28.5 meter girder was found 33170 joule and in other two girders it was 9423.54 joule and 1754.1 joule for 22.5 meter and 16.5 meter respectively. If we see the difference in the length of girder, then the difference in the strain energies is more than 3three times each other. The similar pattern was noticed in the double and tripled layer laminated girder of all three sizes. Similarly, in the shorter span, the reduction in strain energy was not as much as seen in the composite retrofitted girder. In the 22.5 meter un-retrofitted girder the strain energy was found 9594.34 Joule and decreasing very minutely when the number of layers was increased to double and triple. A similar pattern was continued in the 16.5m long girder.

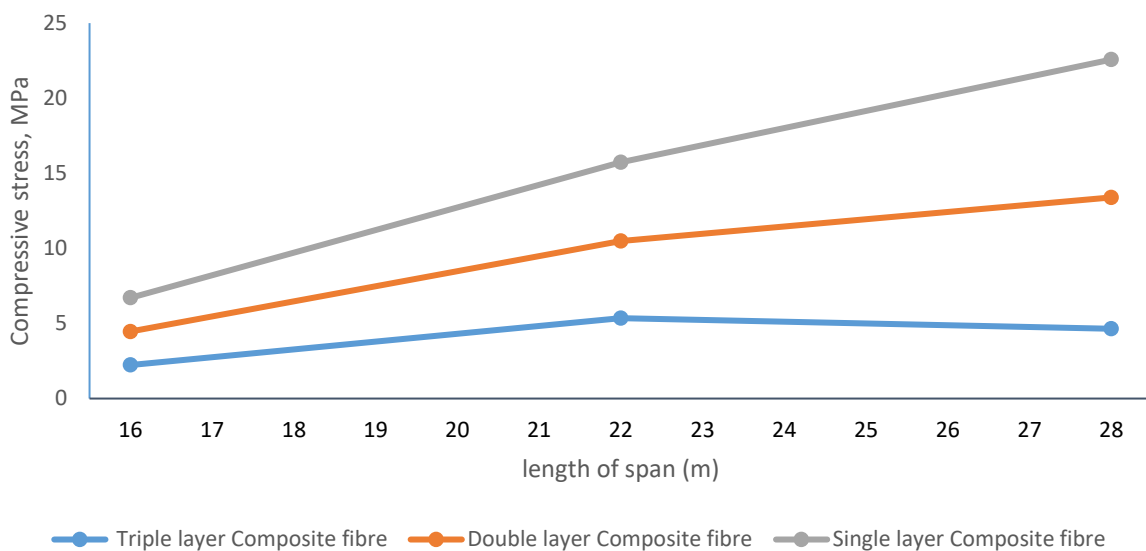
Figure 4. 17 Compressive stress vs span length for different composite layer combination

When all the five girders were retrofitted by both carbon and glass fibre the maximum compressive stress was found 9.17 MPa for 28.5 meter span in single layer fibre and reduced this by approximately 50.5 percent when the layers were tripled in the same beam. For the

girder of 22.5 meter length it was 5.24 MPa for the longest span and reduced to 5.35 MPa when increased the layer of the girder to three. For the 16.5 meter span and single layer lamination, the stress was 2.24 MPa and reduced to 2.22 MPa when it was wrapped by the triple layer. The compressive stress in the double layer lamination is found as 8.73 for 28.5 meter span and 5.13 MPa while 5.13 MPa and 2.23 MPa for 22.5 and 16.5 meter span (Figure 4.17).

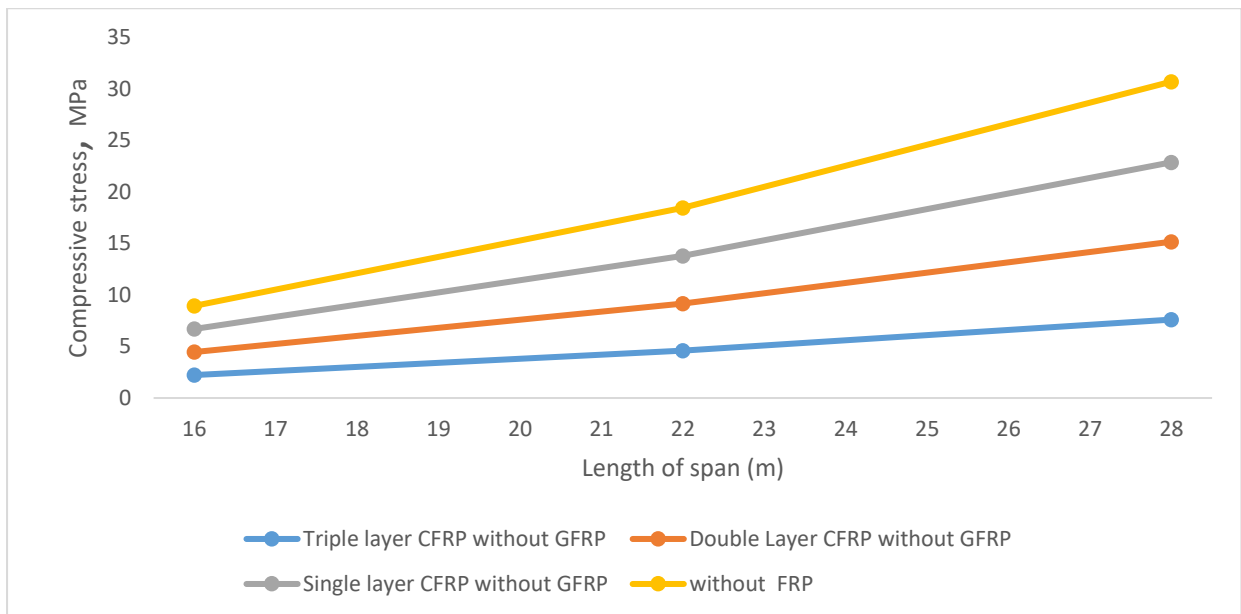
Figure 4. 18 Compressive stress vs span length for different CFRP combination

In the case of carbon laminated girder of length 28.5 meter, the compressive stress was found 7.70 MPa for single layer and reduced it to 7.61 MPa for triple layer lamination. When the girder became slightly smaller of length 22.5 m then the compressive stress for single layer was found 4.6 MPa and reduced to 4.5 MPa for three layer laminated girder. For the 13.67 meter long girder, the compressive stress was 2.24 MPa in single laminated cases and 2.20 MPa for triple layer lamination (Figure 4.18).

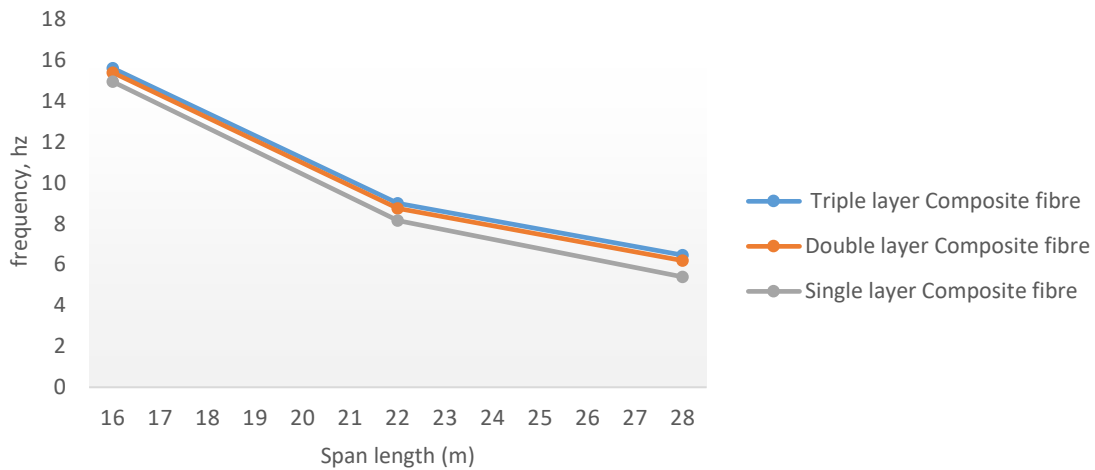
Figure 4. 20 Frequency vs span length for different composite layer combination

To find out the vibration (mode shape, natural frequency) the modal analysis of any structure is advantageous. It can represent any structure's motion under dynamic loading because of lateral force originated by electrostatic impellers. In figure 4.20 and figure 4.21 the frequency of different lengths of girder was examined in three cases without any fibre, with composite fibre and with carbon fibre. The result are compared with each span length and also with the different layers of fibres. Figure 4. 21 Consists the frequency of girder of different length and wrapped with carbon fibre only. The frequency of un-laminated largest girder was found 14.95 Hz while for 22.5m and 16.5m girders it was 7.97 Hz and 5.28 Hz respectively. With the triple layer of carbon fibre in the longest girder of span 28.5m the frequency was found 15.62 Hz and for 22.5m and 16.5 meter girders, the frequency was reported as 8. 99 Hz and 6.46 Hz.

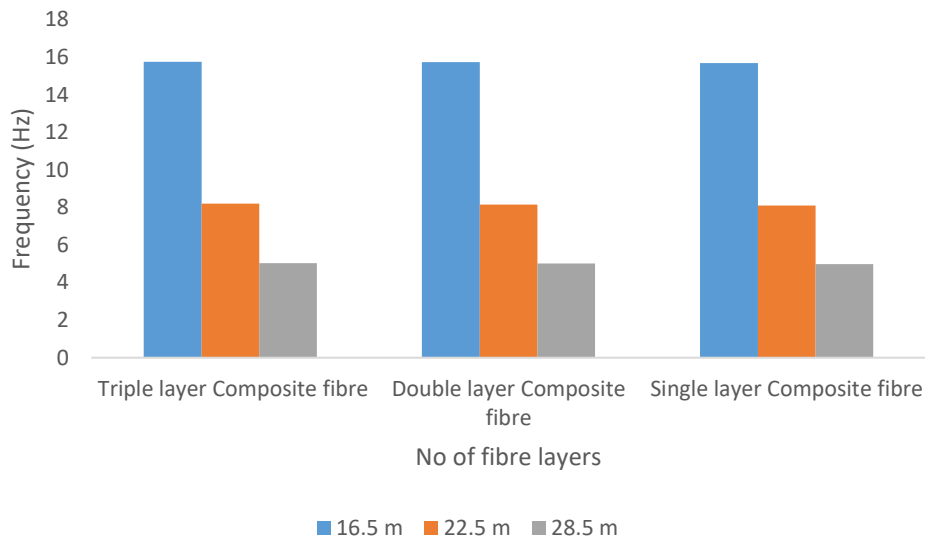
Figure 4. 23 frequency vs nos of fibre layer in mode 2 for different span length

Figure 4. 23 describes the vibrations of girder in mode 2. for single-layer composite laminated girder of length 28.5m the frequency was found 4.98 Hz, In girder length 22.5m and 16.5 meters it was found as 8.09 Hz and 15.689 Hz. Similar pattern was observed in double and triple layer of composite fibre laminated girder. When the girder was laminated only using

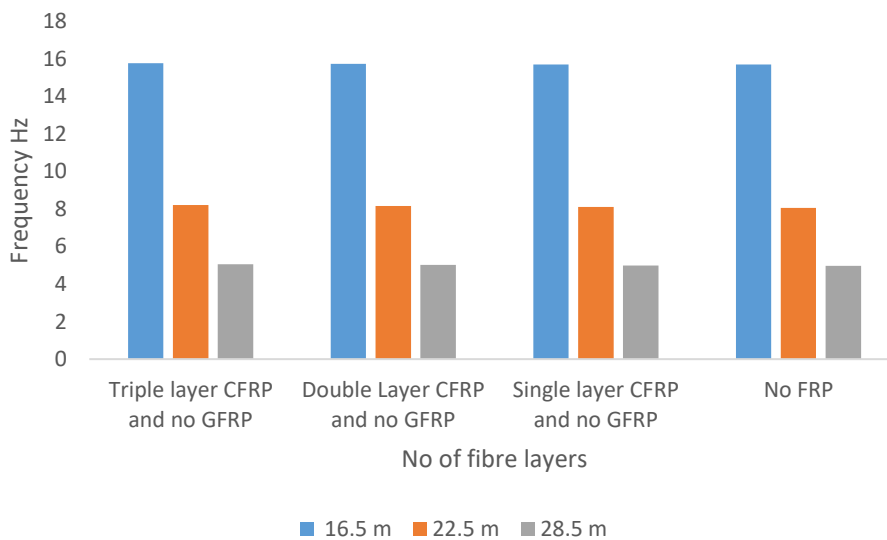
Figure 4. 24 Frequency (mode 2) vs no of fibre layer for different span length

carbon fibre the frequency in mode has been displayed in fig 4.24. In this figure the frequency of triple layer carbon fibre laminated girder of length 28.5 meter was found 5.04 Hz. While other girders of length 22.5 meter and 16.5 meter was noted 8. 20 Hz and 15.75 Hz. the frequency in doubly laminated girder of 28.5 Meter, 22.5 meter and 16.5 meter was relieved as 5.01 Hz, 8. 16 Hz and 15.73 Hz. when the strengthening of girder reduces to the single layer carbon fibre then the frequency in mode 2 was 4.98 Hz in 28.5 meter long girder, 8.09 Hz in 22.5 meter long girder and 15.69 Hz in shortest sample girder. In the case where all girders are un-laminated the frequency was found as 4.96 Hz for 28.5m length, 8.05 Hz for 22.5 meter and 15.68 Hz for 16.5 meter girder (Figure 4.24)

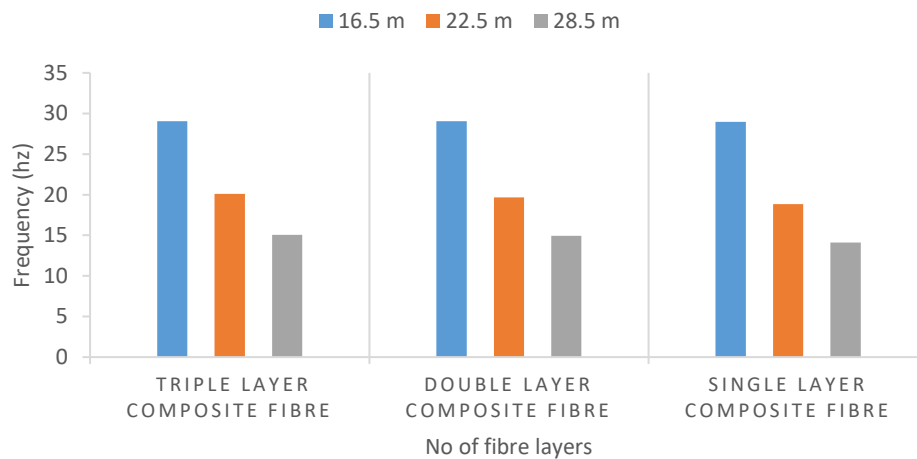
Figure 4. 26 frequency vs. nos. of fibre layer in mode 3 for different span length

Figure 4.26 and 4.27, describes the frequency of all the three different length girder for mode shape 3 which was retrofitted in two different types of fibre combination i.e. first with composite fibre of carbon and glass, and second only strengthen by Carbon fibres. In figure 4.26 it can be seen that the Single layer Composite fibre when applied in longest span then the frequency obtained Comes to 14.10 Hz and when it was applied to 22.5 meter and 16.5 meter long girder the frequency was reported 18.82 Hz and 28.95 Hz. It can also be concluded that

the frequency difference in the shortest and longest sample girder was just more than double. The frequency for double and triple-layer composite fibre of span 28.5 meter was 14.95 and 15.04 respectively and for span 22.5 meter and 16.5 meter it was confirmed to 19.68 Hz, 20.03 Hz and 29.04, 29.06 Hz, respectively. Analysis of modal frequency depicts about the dynamic properties of the tested structure. The primary objective of this analysis was to find out the mode shape and frequency of girders.

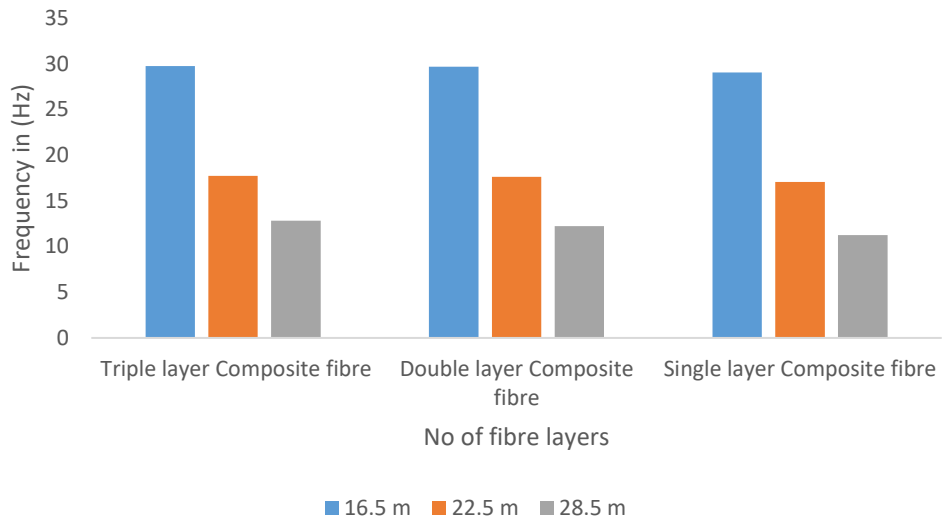
Figure 4. 29 Frequency vs Nos of fibre layer in mode 4 for different span length

Figure 4.29 and figure 4.30 Contain frequency in mode 4 with and without glass fibre while carbon fibre was always in flexure. Figure 4.29 the single layer Composite fibre wrapped girder showed more than 2.5 times frequency in the the shortest girder than the longest girder of case. This trend was continued in double and triple layered girder too. In figure 4.30 the frequency of single layered carbon strengthened girder of span length 28.5 meter was noted as 11.27 Hz while girder of length 22.5 meter and 16.5 meter was found a 17.08 Hz and 29.84 Hz respectively. When the Carbon fibre layered was increased in all the girder the frequency obtained in 28.5 meter, 22.5 meter and 16.5m girder was 12.22 Hz, 17.61 Hz, and 29.46 Hz respectively. Similarly the frequency in all the three carbon swaddled girders in descending order was found at 12.8 Hz, 17.73 Hz and 29.7 Hz.

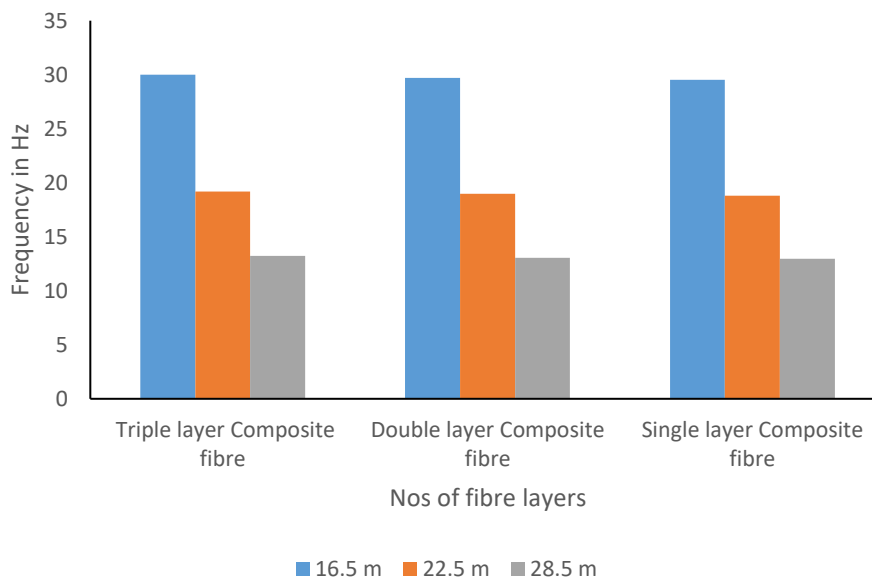
Figure 4. 32 frequency vs nos. of fibre layer in mode 5 for different span length

Figure 4.32 and figure 4.33 represents the frequency of laminated girder in mode shape 5. In figure 4.32 the single layer composite fibre on the girder of length 28.5 meter showed the frequency of 12.94 Hz and the girder of 22.5m and 16.5m showed the 18.78 Hz and 29.52 Hz respectively. The double layered composite fibre of longest girder showed the frequency of 13.06 Hz and other two girder in descending order showed 18.96 and 29.70 Hz respectively. Similar stance was observed in triple Layered girders of all the three spans. In figure 4.33 the mode shape 5 and frequency for three different spay and three type of Carbon fibre arrangement were compared. In the first combination the single layer carbon fibre on the girder of three different span i.e. 28.5 meter 22.5 meter and 16.5 meter was applied and frequency was measured for mode shape 5. The frequency for the largest and second-largest girder was 12.94 Hz and 18.78 Hz. The frequencies in the smallest girder after lamination of single layer was found the highest and it was 29.52 Hz. For the double layer, the 28.5 meter girder frequency was noted 13.06 Hz and the girder with 22.5-meter span and 16.5 meter span reported their

frequency 18.97 Hz and 29.73 Hz, respectively. A similar Easel was noticed for next added layer of FRP.

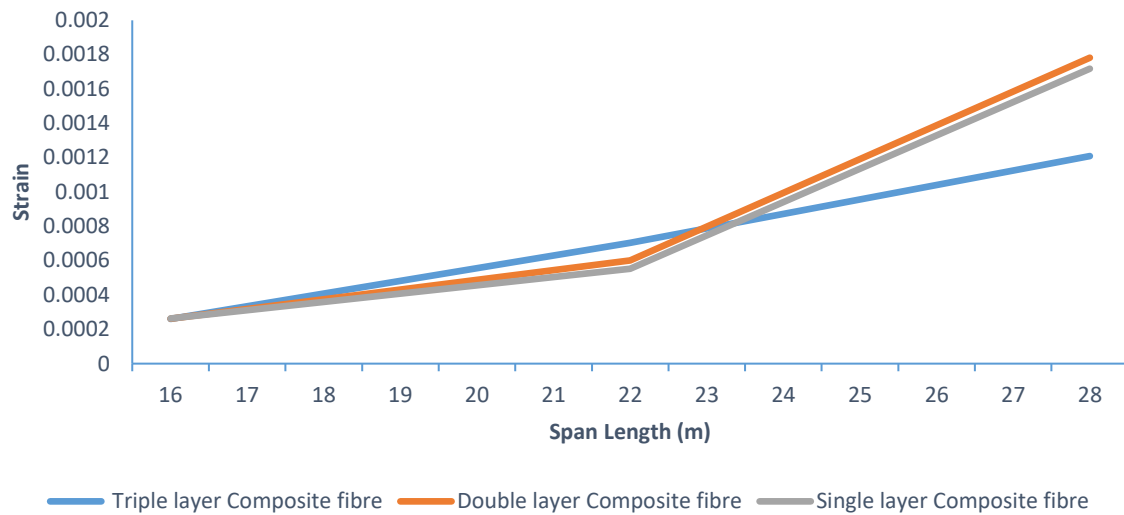
Figure 4.34 Max. Von-Mises strain vs span length for different composite layer

Figure 4.34 and Figure 4.35 confirmed that every laminated bridge girder experiences the yielding before going in failure mode as their Von Mises strain is greater than their simple deformation in each case. In figure 4.34 the single, double and triple-layer composite fibre stratum on all the three girder of the sample. In the single layer and longest girder the strain was found 1.72 mm while it got reduced by 50 percent in the case of triple layer composite fibre on the same length of girder. The Von misses strain on the single layer laminated girder of 22.5 meter and 16.5 meter length is 0.55 mm and 0.26 mm. when the composite fibre layer tripled the strain found as 1.2 mm, 0.70 mm and 0.26 mm for descending length of all girder. Figure 4.35 consist the Von-Mises strain of girders which was laminated only using the carbon fibre only. The single-layered girder of 28.5 meter length showed Von-Mises strain of 0.81 mm while other two girder of comparatively smaller length are showing 0.54 mm and 0.26 mm for

22.5 meter and 16.5 meter respectively. The similar trend was observed in the double and triple layered girder.

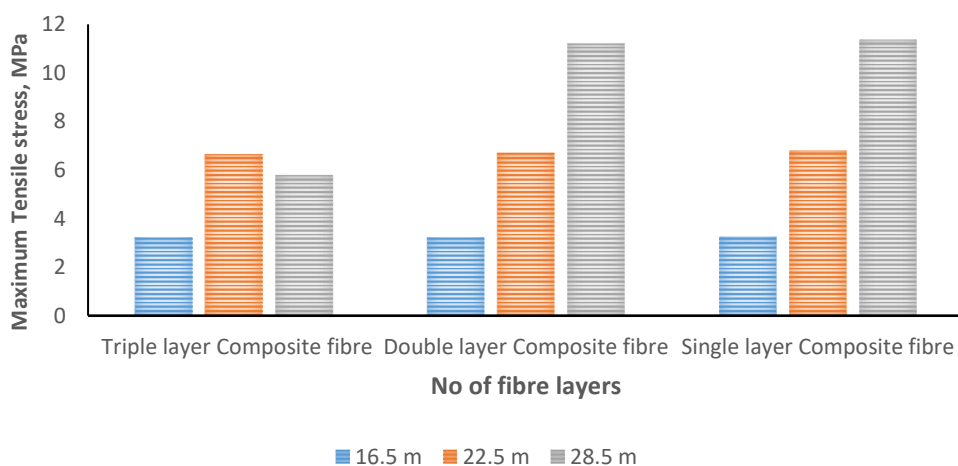
Figure 4. 36 Max tensile stress vs no of fibre layer for different span length

reason, then the tension zone's strengthening is constitutive. Figure 4.36 assured that the effect of multiple layer FRP increased the strength of concrete considerably in the tension zone. In this figure the maximum tensile stress in singly, doubly and triple layer wrapped girder of three different length is being analysed. In the first case of the girder length 28.5 meter was singly wrapped have stress of 11.36 MPa, 6.8 Mpa for the 22.5 meter long girder and 3.22 MPa for 16.5 meter girder. As the strengthening of all girder was completed and tested again the maximum reduction was observed in the longest girder about 100 percent. In double coated lamination the stress in longest girder of 28.5 meter length it is 11.20 MPa, in 22.5 meter long girder it is 6.71 MPa and in shortest girder it is 3.21 MPa. In the three-layered girder case the maximum stress was not occurred in longest one as it happened in the fore cases. Here the maximum stressed girder was the second largest i.e. 22.5 meter long girder.

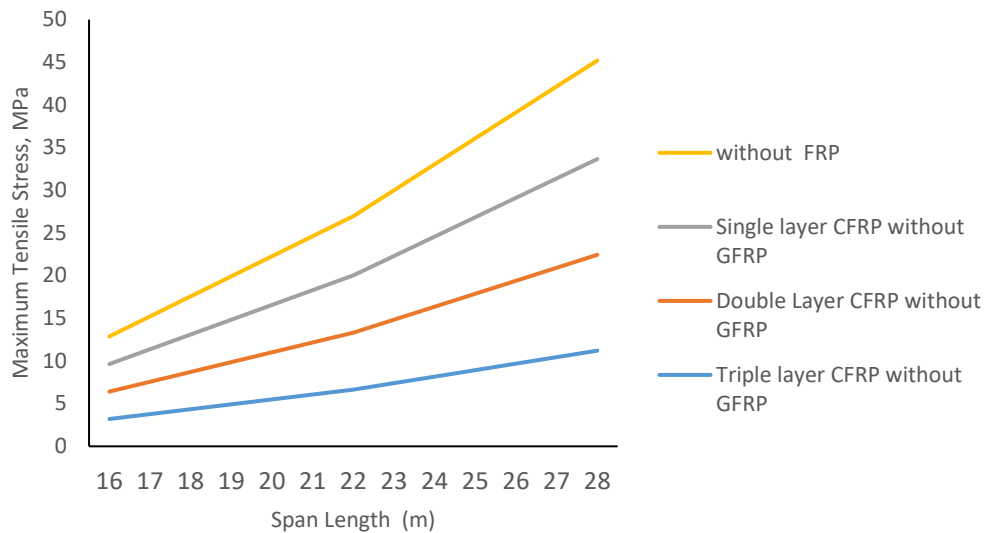
Figure 4. 37 Max tensile stress vs span length for different CFRP layer combination

Figure 4.37 proved that without glass fibres there would be no such increment in the tensile strength of concrete. The reduction in the tensile stress in all the girder was not as found in composite fibres.

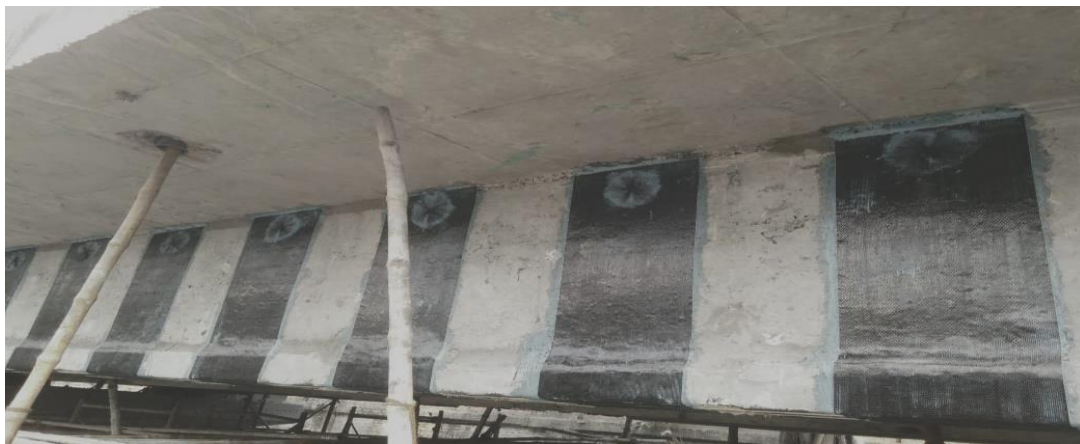
Figure 4. 41 Girders strengthened by fibre reinforced polymer

Following procedures have been adopted for repair and strengthening of Distressed R.C. girders.

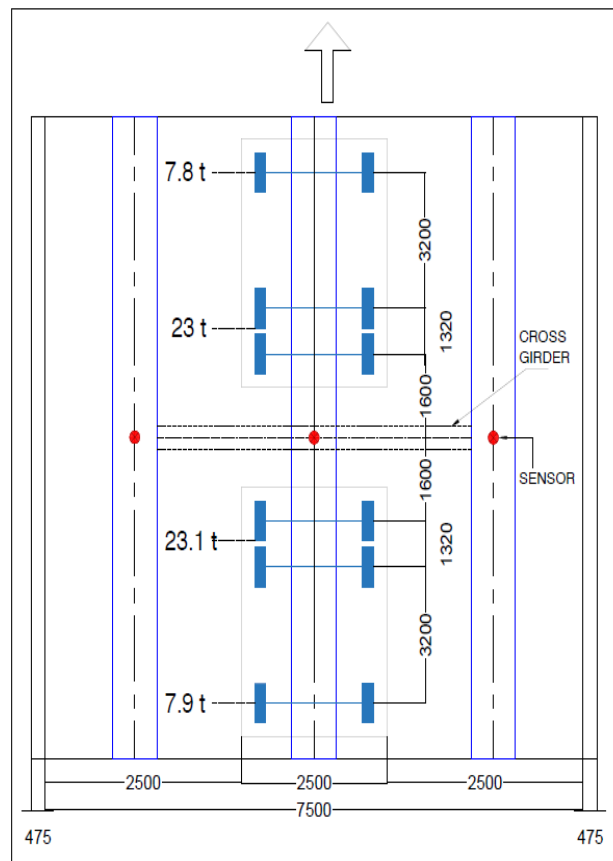
Figure 4. 43 Arrangement and axle load of two trucks for center (top view)

- Centre Loading- The trucks were placed back to back at the center as shown in figure 4.43 to create a maximum bending moment in the central girder as the maximum load is coming directly over this girder.
- Left Lane Loading- The trucks were placed back to back on the left lane as shown in figure 4.44. In this case the maximum load is coming on left girder.
- Right Lane Loading- The trucks were placed back to back on the right lane as shown in figure 4.45. In this case the maximum load is coming on right girder.

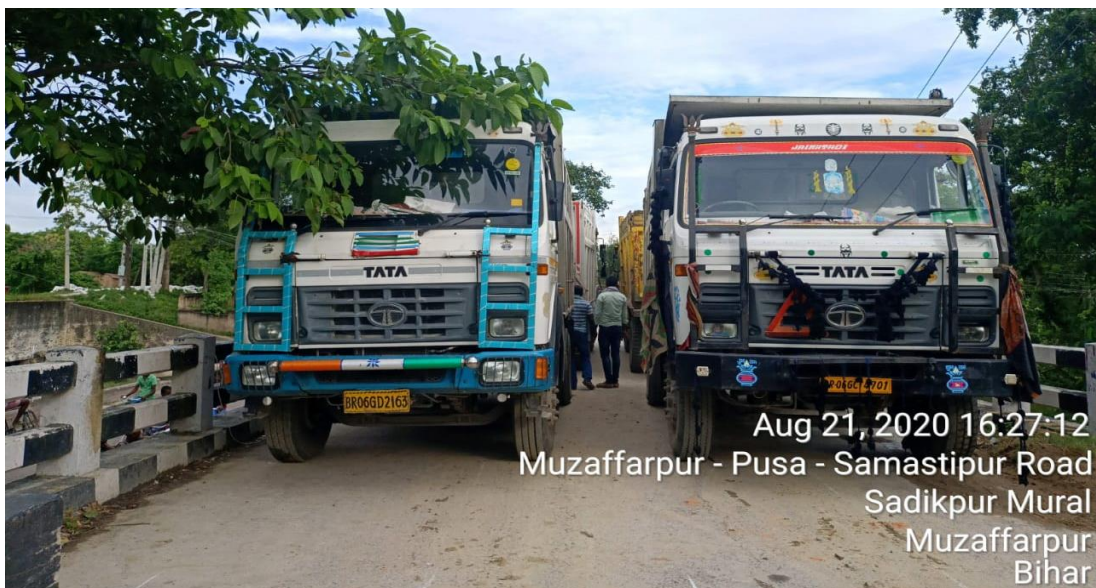
Figure 4. 47 Loaded trucks placed for static load testing

Static and dynamic load tests were performed to know the behavior of girders in flexure under vehicular load. The load tests have been carried out by placing the vehicles at different deck locations to capture all girders' behavior for maximum loaded critical conditions. The trucks were placed back to back as shown in figure 4.47 , to generate maximum absolute bending moment and deflection in the girders.
