**ANALYSIS AND STRENGTHENING OF RAIL BRIDGE GIRDER AT RATLAM:  
A CASE STUDY**

**5.1 General**

## **5.2 Background of bridge no 114**

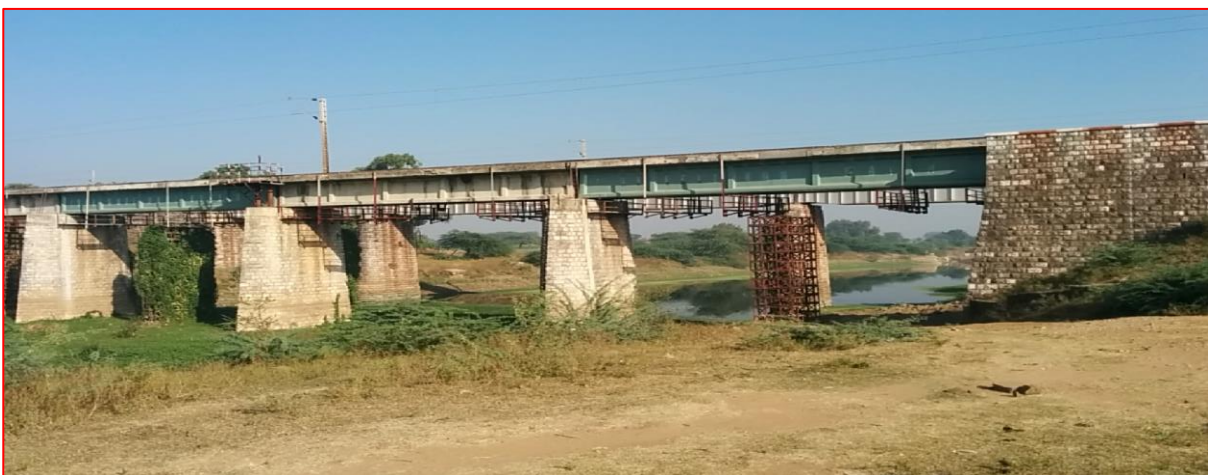
Figure 5. 1 Site view of bridge no 114

The bridges have composite PSC I-girders supported on neoprene bearing (Figure 5.1) with the girder length of 19.67 meter. The schematic diagram is presented in figure 5.2. The details of the bridge are shown in Table 5.1

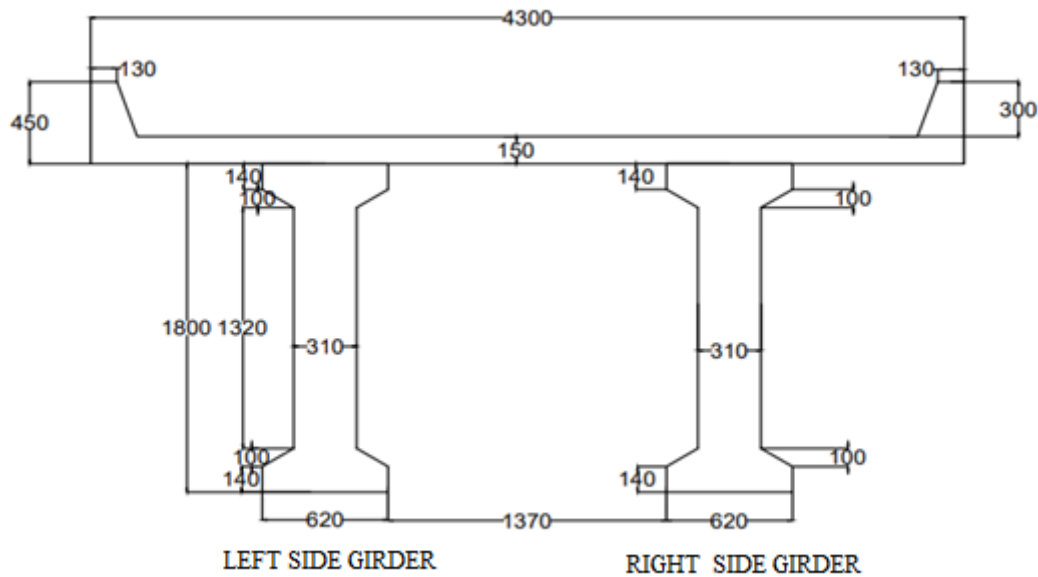
Figure 5. 3: Typical cross section of the bridge

The carriage width of span is 4.3 meter and deck slab is rested on two longitudinal I-girder of span 13.67 meter. The detail cross section is shown in figure 5.3

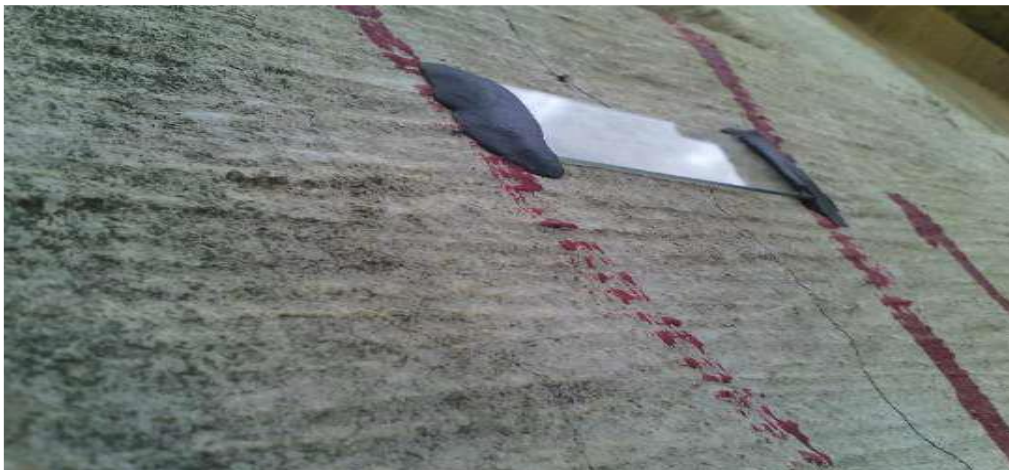
Figure 5. 4 Severe cracks observed in girder

1. The PSC I girders show vertical cracks from the bottom of the girders. (Figure 5.4).
2. Severe deterioration of the diaphragm was observed.
3. Corroded reinforcement exposure is observed at the bottom slab. Figure 5.5
4. Spalling of concrete is observed in the diaphragm bottom
5. Cracks at the girder bottom at bearing locations are observed (Figure 5.6).
6. Severe deterioration at intermediate span locations is seen
7. Discoloration due to deterioration with time is seen in the overall structure
8. Termite attack is observed in the girders.

As per the result of finite element analysis, it is suggested to strengthen the bridge according to the size of its girder. The effective length of girder of bridge no 114 is 19.67 meter. So, according to the recommendation, the flexure zone of the girder will be laminated by three layer of carbon fibre reinforced polymer and shear strengthening will done using glass fibre reinforced polymer as shown in Figure 5.35. The anchors of carbon fibre will be installed at a distance of 250 mm. the width of glass fibre is 500 mm as shown in Figure 5.35 and the site image of fibre wrapping in Figure 5.36. The application of fibres at site is represented in figure 5.37.

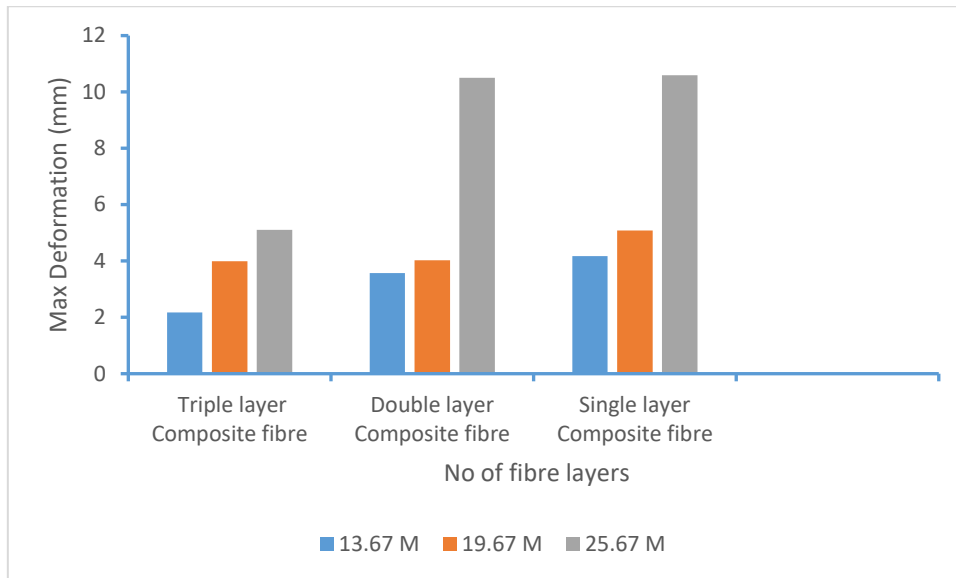
**Figure 5. 10** Max deformation vs no of layer with varying length of girder

The deformation due to live load has been displayed after finite element analysis of girder for different IRC loads. Few apparent changes has observed when the layers of composite fibre were increased. In Figure 5.10 it is clearly visible that for the longest span of bridge i.e. 25.67 m, the deformation was vastly reduced when the layer of composite fibres CFRP and GFRP were tripled. In the case 1 when the length of the girder was 13.67 meter and the single layer

of composite fibre were glued then the deformation in the girder was 4.1749 mm when this layer increased by one layer then the deformation was found 3.5725 mm and in the case of triple layer it decreased and reached to 2.171 mm. In case 2 when the length of girder was 19.67 meter, the deformation in the single layer fibre 5.08 mm, in the double layered fibre, was 4.02 mm and in the triple layered fibre it came to 3.99mm.

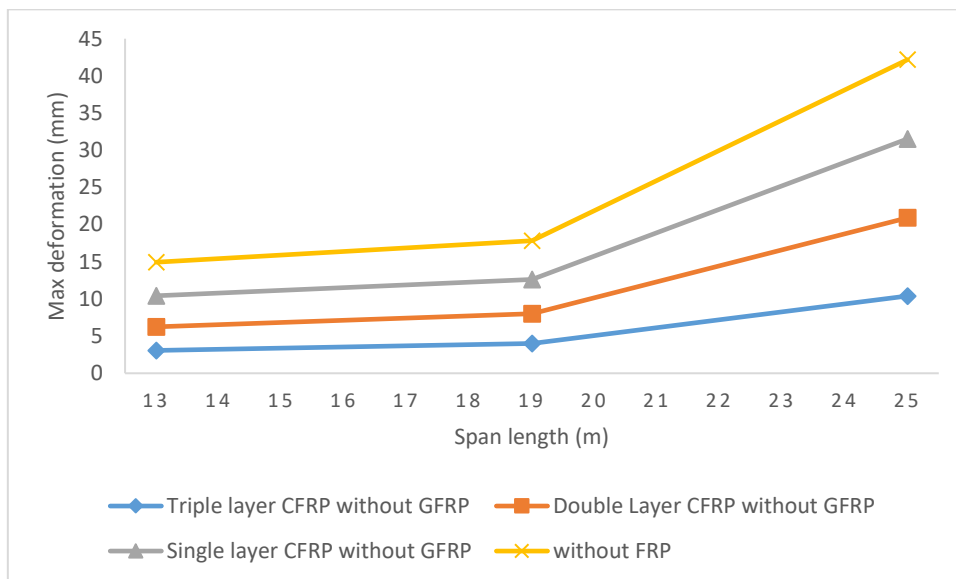
**Figure 5. 11** Max deformation vs length of girder with varying fibre layer

The girder was again modelled without glass fibres (Figure 5.11) with the increasing number of layers of carbon fibres for all the three girder of 13.67mm, 19.67 mm and 25.67mm. In the case of 13.67 meter the deformation of the girder when there was no fibre, was found 4.517 mm. with the single layer of carbon fibre it was 4.17 mm, as doubled the layers for this girder the deformation came to 3.17 mm and in the three time CFRP wrapped girder the deformation was found 3.07 mm. for the second girder whose length was 19.67 meter the deformation was 5.21 mm in no fibre strengthening case. The deformation was reduced and reached to 4.58 mm when single layer CFRP was applied similarly, it further sink to 4.02 mm and 3.99 mm for two and three layer lamination of girder. The third girder with span length 25.67 meter was examined wrapped similarly by one, two and three layer of carbon fibre and the deformation was noticed 10.61 mm, 10.51 mm and 10.39 mm respectively.

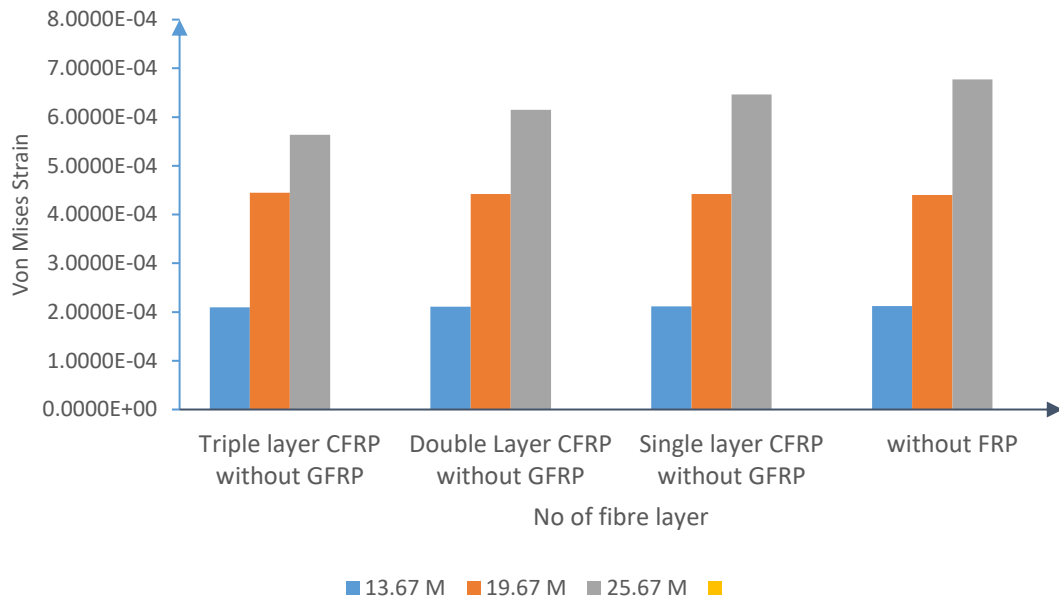
**Figure 5. 13** Maximum von misses strain vs span length for carbon fibre

Figure 5.13 consist the von-mises strain of girders which was laminated only using the carbon fibre only. The single layered girder of 25.67 meter length showed von mises strain of 0.81 mm while other two girder of comparatively smaller length are showing 0.54 mm and 0.26 mm for 19.67 meter and 13.67 meter respectively. The similar trend was observed in the double and triple-layered girder.

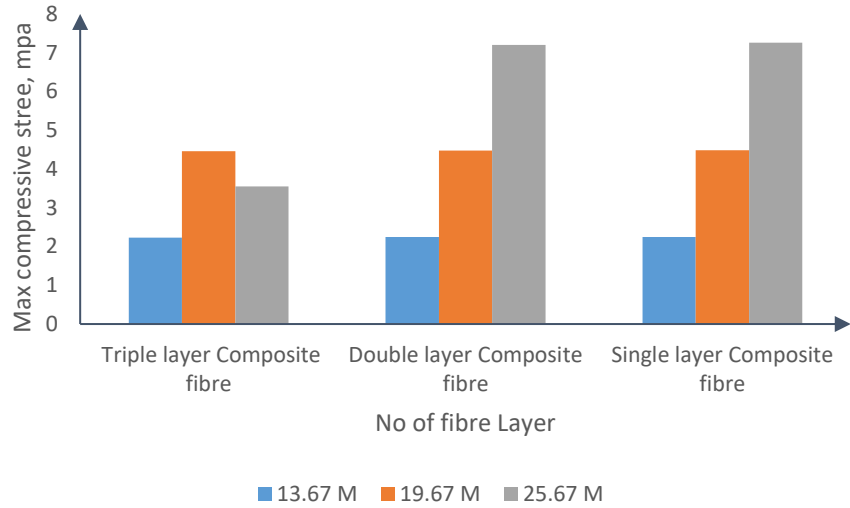
**Figure 5. 14** Maximum compressive stress vs fibre layers

When all the five girders were retrofitted with both carbon and glass fibre the maximum compressive stress was found 7.25 MPa for 25.67 meter span in single layer fibre and reached this value to 3.54 MPa when the layers were tripled in the same beam. For the girder of 19.67 meter length, it was 4.47 MPa for the longest span and reduced to 4.3 MPa when increased the girder layer to three. For the 13.67 meter span and single layer lamination, the stress was 2.2 MPa and reduced to 2 MPa when it was wrapped by triple layer. The compressive stress in the double layer lamination is found as 7.2 for 25.67-meter span while 4.47 MPa and 2.24 MPa for 19.67 and 13.67-meter span. (Figure 5.14)

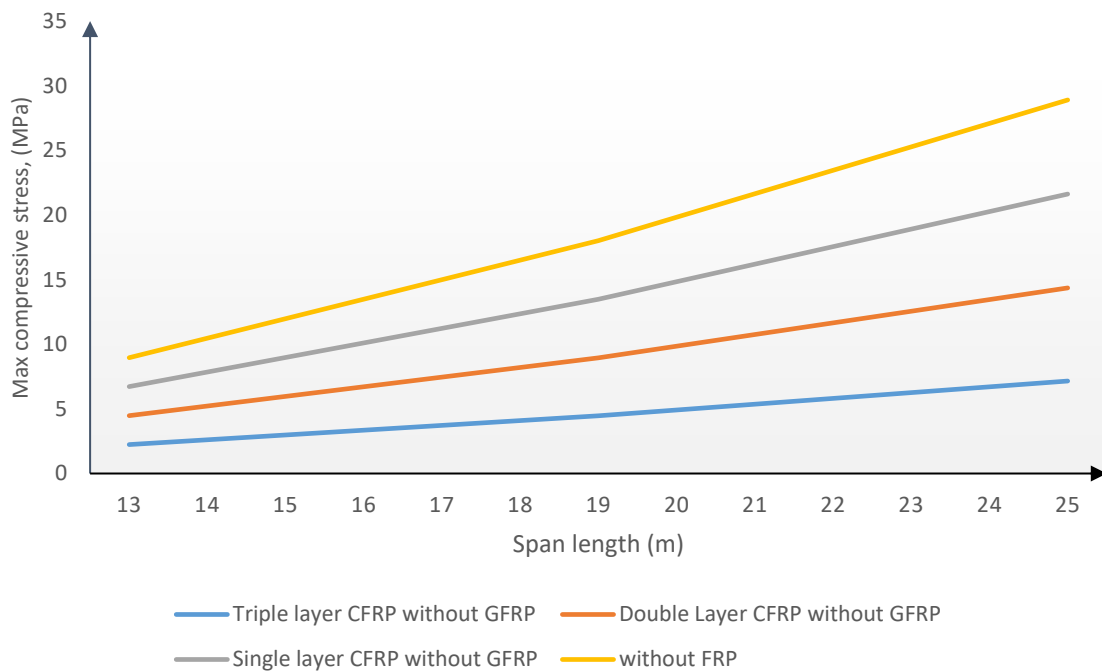
**Figure 5. 15** Maximum compressive stress vs span length

In the case of carbon laminated girder of length 25.67 meter, the compressive stress was found 7.2 MPa for single layer and reduced to 7 MPa for triple layer lamination. When the girder became slightly smaller of length 19.67 m, the compressive stress for a single layer was found to be 4.5 MPa and reduced to 4.4 MPa for three layer laminated girder. For the 13.67 meter

long girder, the compressive stress was 2.2 MPa in single laminated cases and 2.20 MPa for triple layer lamination.(Figure 5.15)

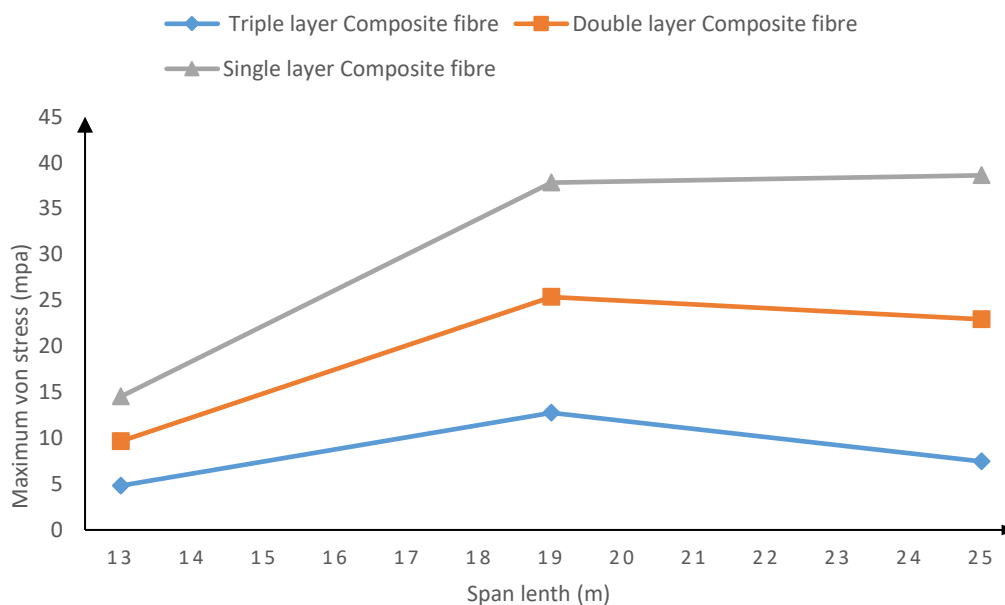
**Figure 5. 18** Max Von Mises stress vs length of girder with varying fibre layer

Figure 5.18 the von Mises stress of any structure describes its ability to yield before discomfiture. The Figure 5.12 consist the behavior of composite laminated girders. The stress in single-layered laminated girder the von Mises stress was found 15.67 MPa for the longest span which was 25.67m. Respectively for the double and triple layer it was 15.48 Mpa and

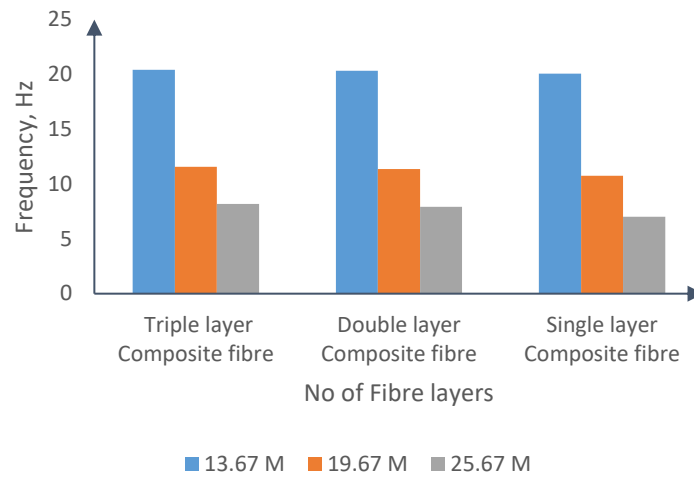
**Figure 5. 22** Frequency vs no of fibre layers mode shape 1

To find out the natural frequency of girder five-mode shape, we have analyzed use and for each mode, the cases of composite fibres and without glass fibre have been discussed. In Figure 5.22 for mode 1 the frequency of single layer composite fibre of largest girder i.e. 25.67 meter was found 7.01 Hz and of second girder it is found 10.749 and for smallest girder it was found 20.06 Hz.

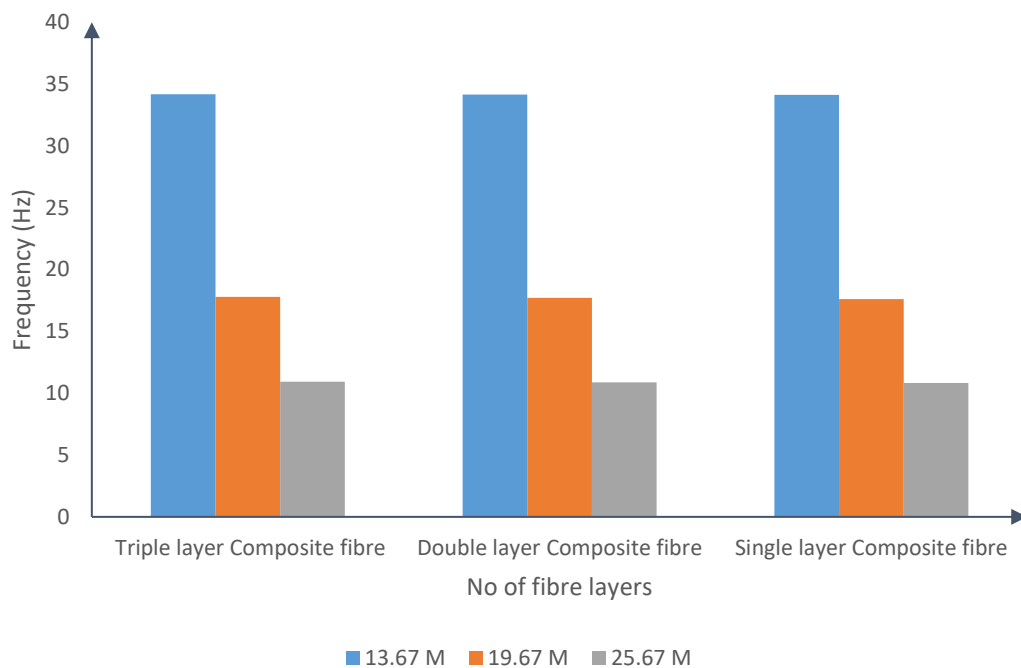
Figure 5. 24 Frequency vs span length in mode shape 2

Figure 5. 24 describes the vibrations of the girder in mode 2. for single-layer composite laminated girder of length 25.67m the frequency was found 10.83 Hz, In girder length 19.67m and 13.67 meter it was seen as 17.59 Hz and 34.11 Hz. A similar pattern was observed in double and triple layer of composite fibre laminated girder. When the girder was laminated only using carbon fibre the frequency in mode has been displayed in figure 5.25. In this figure

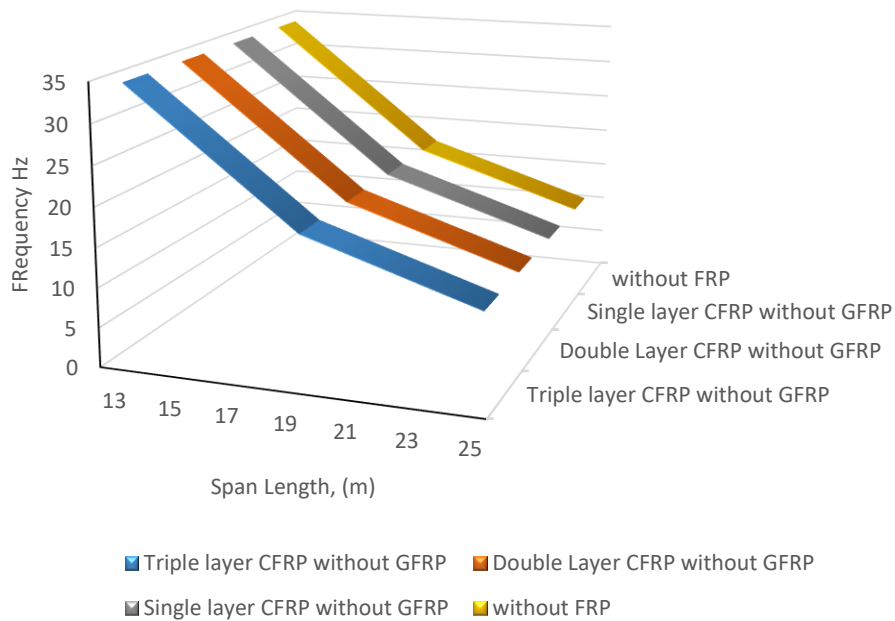
**Figure 5. 25** Frequency vs span length in mode shape 2

the frequency of triple layer carbon fibre laminated girder of length 25.67 meter was found 10.94 HZ. While other girders of length 19.67 meter and 13.67 meter was noted 17.79 Hz and 34.17 Hz. the frequency in the doubly laminated girder of 25.67 Meter, 19.67 meter and 13.67 meter was relieved as 10.88 Hz, 17.72 Hz and 34.15 Hz. when the strengthening of girder reduces to the single-layer carbon fibre than the frequency in mode 2 was 10.83 Hz in 25.67 meter long girder, 17.60 Hz in 19.67-meter long girder and 34.11 Hz in shortest sample girder. In the case where all girders are un-laminated, the frequency was found as 10.81 Hz for 25.67m length, 17.52 Hz for 19.67 meter and 34.11 Hz for 13.67 meter girder.

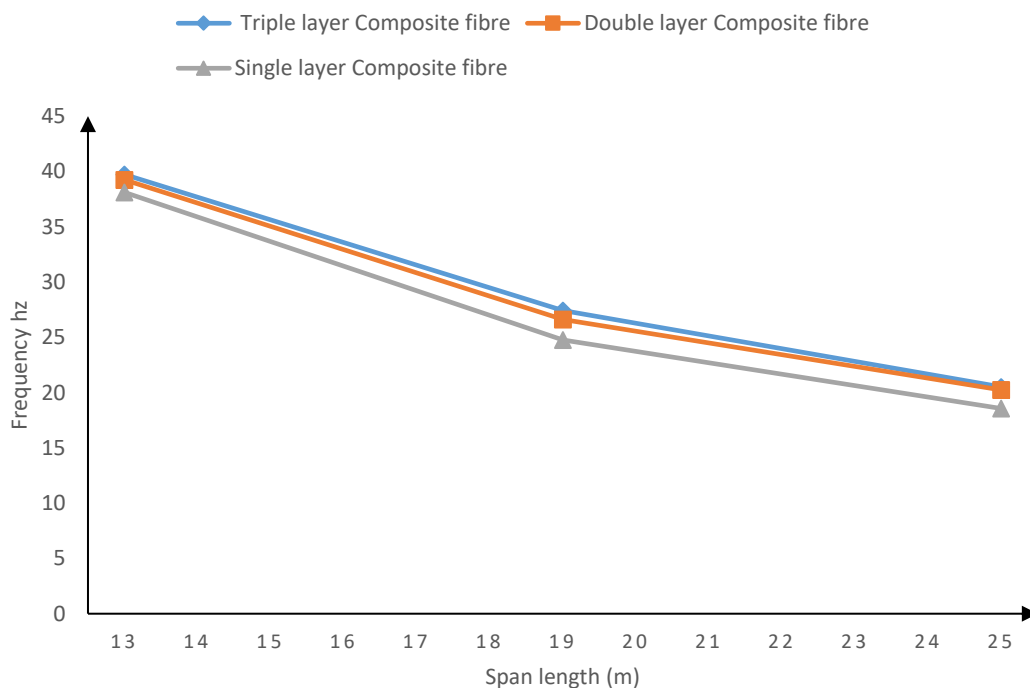
**Figure 5. 27** Frequency vs span length in mode shape 2

Figures 5.27 and 5.28 describe the frequency of all the three different length girder for mode shape 3 which was retrofitted in two different types of fibre combination i.e. first with composite fibre of carbon and glass, and second only strengthen by Carbon fibres. In Figure 5.27 it can be seen that the Single layer Composite fibre when applied in longest span then the

Figure 5.27 and 5.28, describe the frequency of all three different length girders for mode shape three, which was retrofitted in two different types of fibre combination i.e. first with the composite fibre of carbon and glass, and second only strengthened by Carbon fibres. In Figure 5.27 it can be seen that the Single-layer Composite fibre when applied in the longest span then the frequency obtained comes to 10.82 Hz and when it was applied to 19.67 meter and 13.67 meter long girder the frequency was reported 17.60 Hz and 34.12 Hz. It can also be concluded that the frequency difference in the shortest and longest sample girder was just more than double. The frequency for double and triple-layer composite fibre of span 25.67 meter was 14.95 Hz and 15.04 Hz and for 19.67 meter and 13.67 meter span it was confirmed to 17.71 Hz, 17.78 Hz and 34.14 Hz, 34.16 Hz respectively.

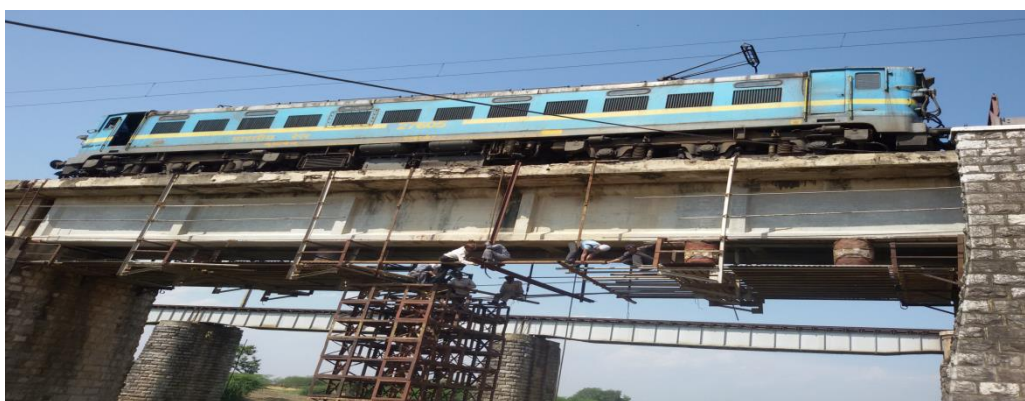
**Figure 5. 38** Load applied on the bridge using wagon 7

Before and after the strengthening of girder as per prescribed fibre layers, the bridges were tested using WAGON 7 locomotive to observe the deflection and natural frequency in the girders with the help of linear potentiometer and accelerometer, as shown in Figure 5.38 then after bridge was strengthened as per the above-prescribed scheme.

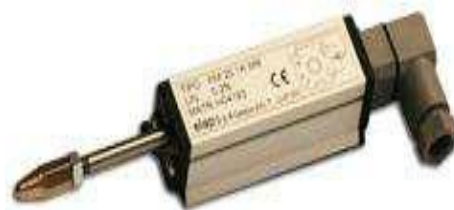
**Figure 5. 39. TIPO PM 25 5K MR**

The maximum deflection in the PSC I girder occurs at the mid-span. An independent platform of steel cribs was provided at the site for the Linear Potentiometer placement after cleaning the surface. The platform to support the linear potentiometer is made to be even, and the same is checked with the spirit level. The linear potentiometer is clamped on its stand which is fixed and secured with the platform. The contact with the bottom chord of the girder is established with the head of the plunger such that the initial reading is recorded with the corresponding change in the voltage. The TIPO PM 25 5K MR Potentiometer was used (Figure 5.39)

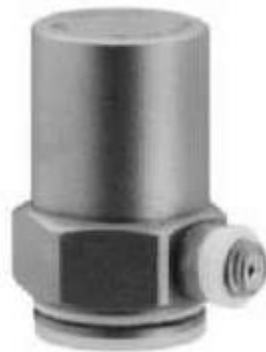
**Figure 5. 40 B& K accelerometer**

The measurement of the Natural frequency of the RCC Girders simply supported over masonry piers was done at mid-span for one cracked span and one uncracked PSC I Girders in the two Spans. Pre-stressed concrete (PSC) bridge girders No 54 have undergone distress with age through loss of pre-stressing force and through the development of structural cracks in the concrete. It is expected that such distress will be reflected through a change of stiffness of the girder. As the stiffness of the girder changes, the natural frequency will also change. Accelerometers are mounted onto the girders for recording the frequency. The motion (or dynamic force) of the vibrating body is converted into an electrical signal by the vibration transducer or pickup.

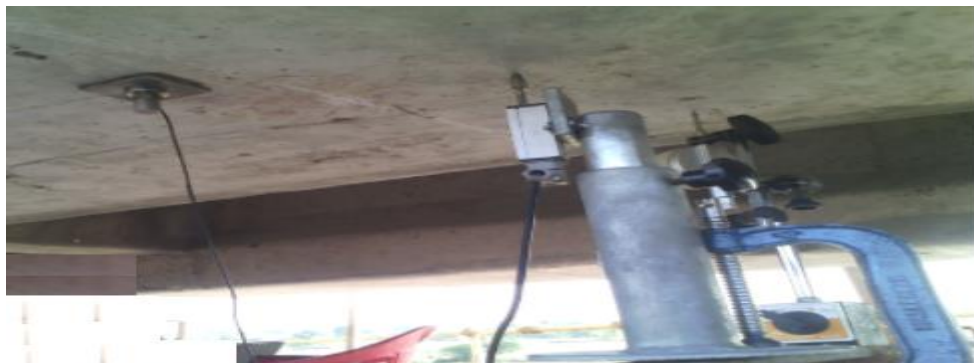
**Figure 5. 41** Arrangement of deflection sensor and accelerometer

The linear potentiometer and accelerometer is fixed in such a way that it is independent of the girder vibrations and other movements (figure 5.41)

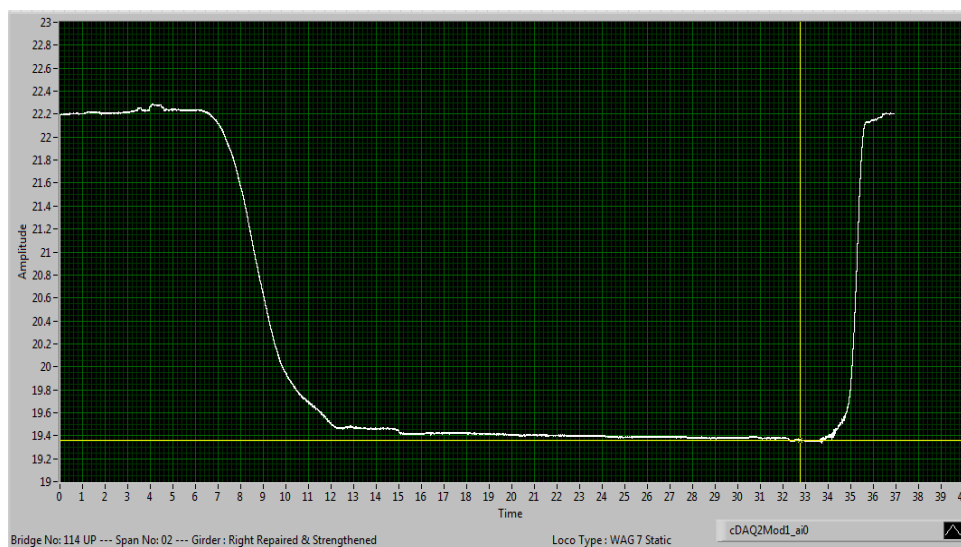
Figure 5. 45 Amplitude vs time for static load after strengthening

After strengthening the girder, the Maximum deflection is decreased compared to pre-strengthening results (Figure 5.45). Under static load, the Initial Amplitude is equal to 22.23 mm, and the final amplitude is equal to 19.36 mm, so the deflection of the girder is equal to  $22.23 - 19.3608 = 2.87$  mm

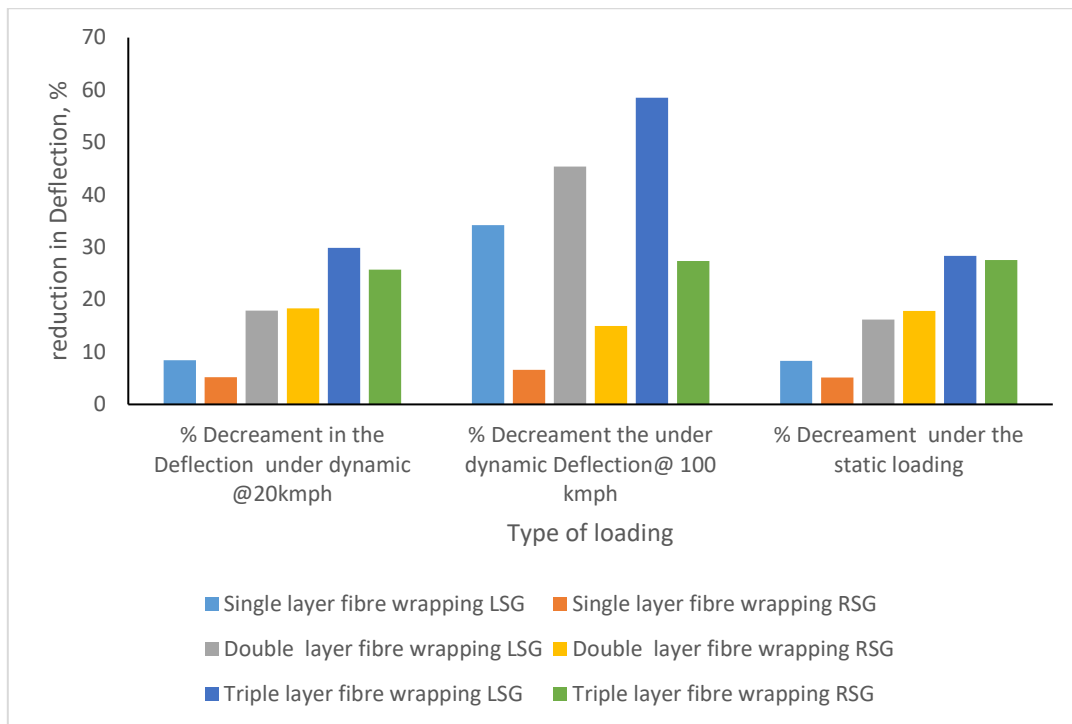
**Figure 5. 48** Reduction in deflection in different loading

In table 5.5 the deflection and natural frequency are listed for different dynamic loading speed and static loading for the various fibre layer wrapping. From table 5.5 it is concluded that the natural frequency with every layer of wrapping of girder increases as compared to unstrengthen girder. The left side girder (LSG) of bridge no 114 has more cracks compared to the right side of the girder. When the static loading applied using WAGON 7 after the single layer fibre lamination of left side girder the deflection is reduced by 8.31 % and in double layer wrapping this decrement in deflection was recorded as 16.16 percentage and in the three layer wrapping of carbon and glass fibre the deflection reduced by 28.36 % in proportion of unstrengthen deflection of LSG. Similarly, for the static load test on the right side of girder (RSG) the deflection reduction in one, two and three-layer was recorded as 5.16%, 17.81 %, and 27.56 %, respectively. The dynamic load test of the girder was recorded on three-speed 20 KMPH, 75 KMPH and 100 KMPH for all the three combinations of fibre layer. The reduction in the deflection was greatly reduced in the 100 KMPH speed of WAGON 7. So it can be concluded that the three layer fibre wrapping in long girders will be highly effective. The reduction in deflection in the dynamic test @100 KMPH in LSG is 34.24 %, 45.40 and 58.54 % in single, double and triple layer of fibre wrapping. At the same time, the deflection reduction in the dynamic test @100 KMPH in the RSG is 6.60%, 14.96% and 27.38% when single, double and triple layering of fibre were applied. This trend was not continued with this intensity in the dynamic loading of 20 KMPH. In this case the reduction in deflection in left side girder is recorded as 8.44%, 17.90% and 21.90%, respectively for ascending order of fibre wrapping. In the right side girder, the dynamic load test reduces deflection by 5.17%, 18.30 % and 25.71 % for one, two, and three layers of fibre wrapping, as shown in Figure 5.48.

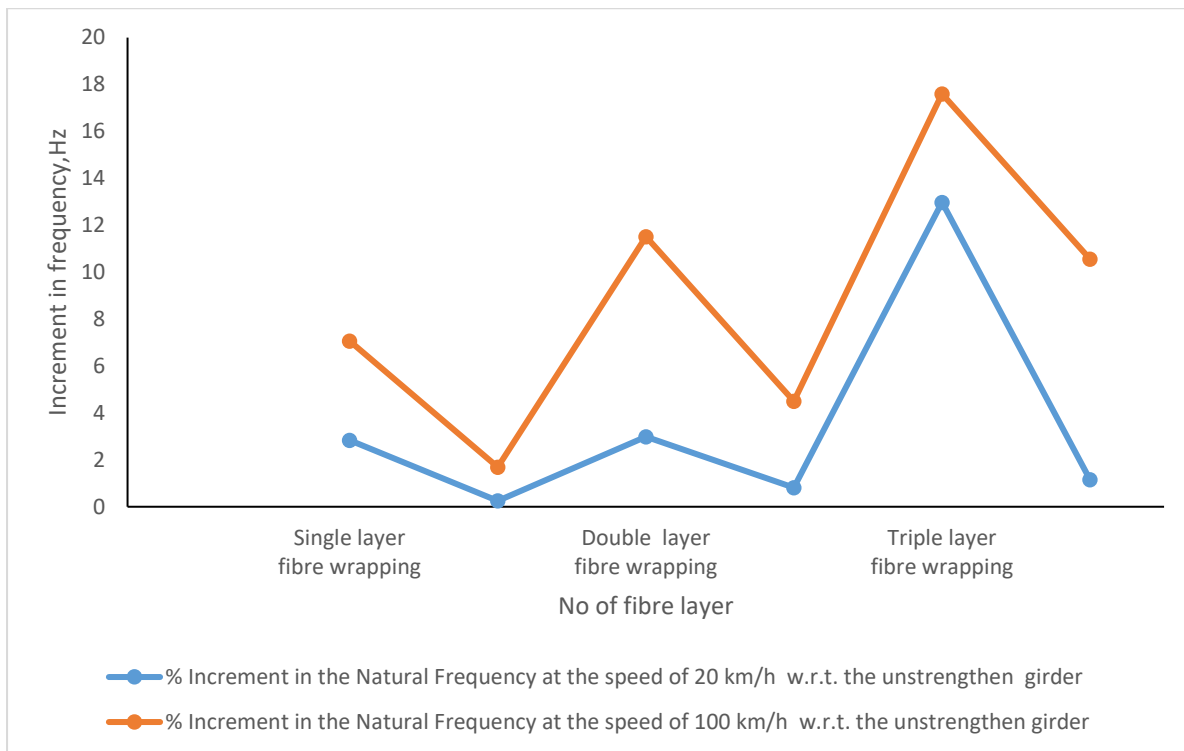
**Figure 5. 49** Change in natural frequency at different fibre layer

Figure 5.49 represents the increment in the natural frequency after the fibre applied on the girder of bridge no 114. The left side girder gives a lower natural frequency than the right side girder as it contained more crack. When the WAGON moves at very low speed of 20 KMPH the frequency increment in the bridge girder was recorded as 2.83, 2.98 and 12.98 percent of unstrengthen girder. In the case of single double and triple layer wrapped at left side girder respectively. In the same speed of the wagon the RSG shows negligible increment. The increment in frequency in RSG is recorded as 0.25%, 0.82%, and 1.15 % in ascending order of fibre wrapping around the girder. The increment in the natural frequency at the speed of 100 KMPH in the LSG is 7.07, 11.51 and 17.60 percent when girder was laminated by one, two and three-layer of fibre wrapping. Similarly, the right side girder of bridge shows the increment as 1.69, 4.5, and 10.56 percent of unstrengthened beam at the wagon speed of 100 KMPH.

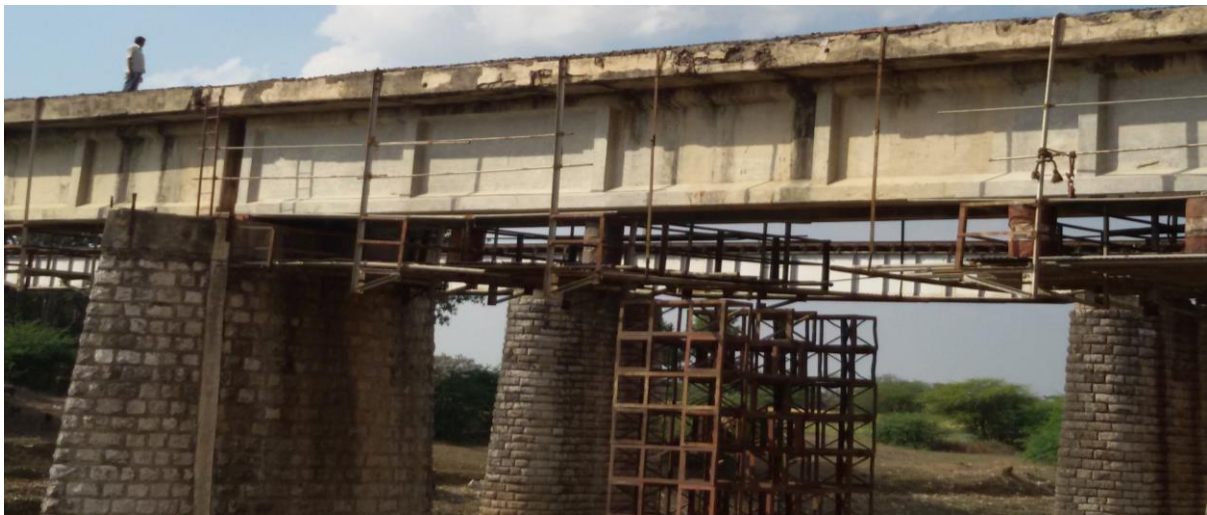
**Figure 5. 50** View of bridge no 54 at site

The Ratlam-Godhra bridge no 54 is located at chainage Km 510/9-15 between station Limkhedha and Mangal Mahudi. (Figure 5.50) The span of the bridge is 13.67 and 19.67 meter long. Each girder consists of 4 diaphragms (2 intermediate and 2 at the end). The weight of a girder is approximately 70 T. the substructure is stone masonry in cement mortar and gravity type. All the section details of the can be seen in Figure 5.51.

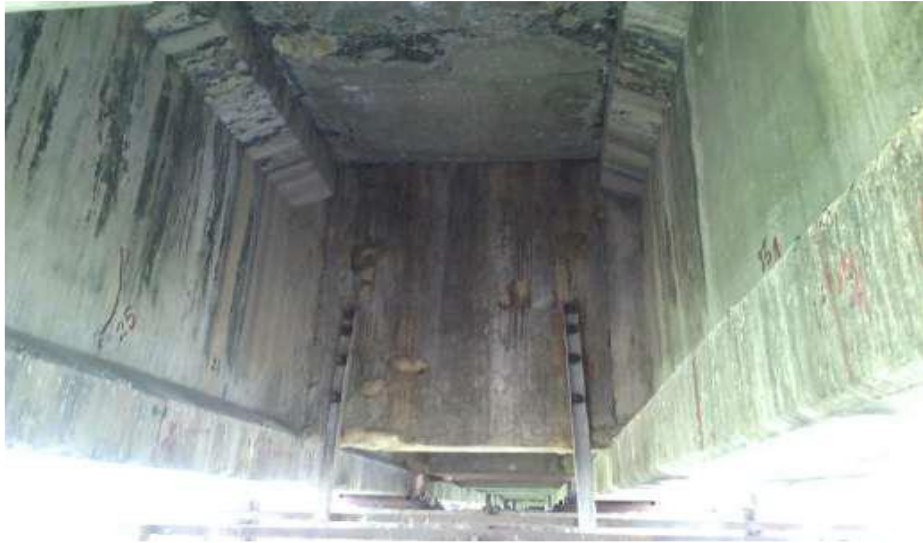
**Figure 5. 52** Severe cracks in girder

1. The PSC I-girders show vertical cracks from the bottom of the girder in Span. (Figure 5.52)
2. The more no cracks on the right side of the girder were observed than on the left side of the girder.
3. Discoloration due to deterioration with time is seen in the overall structure
4. Severe deterioration of the diaphragm observed
5. Severe spalling and corroded reinforcement exposure is observed at the bottom slab.  
This may be attributed to the carbonation that taken place in the structure.
6. Spalling of concrete is observed in the diaphragm bottom (Figure 5.53)

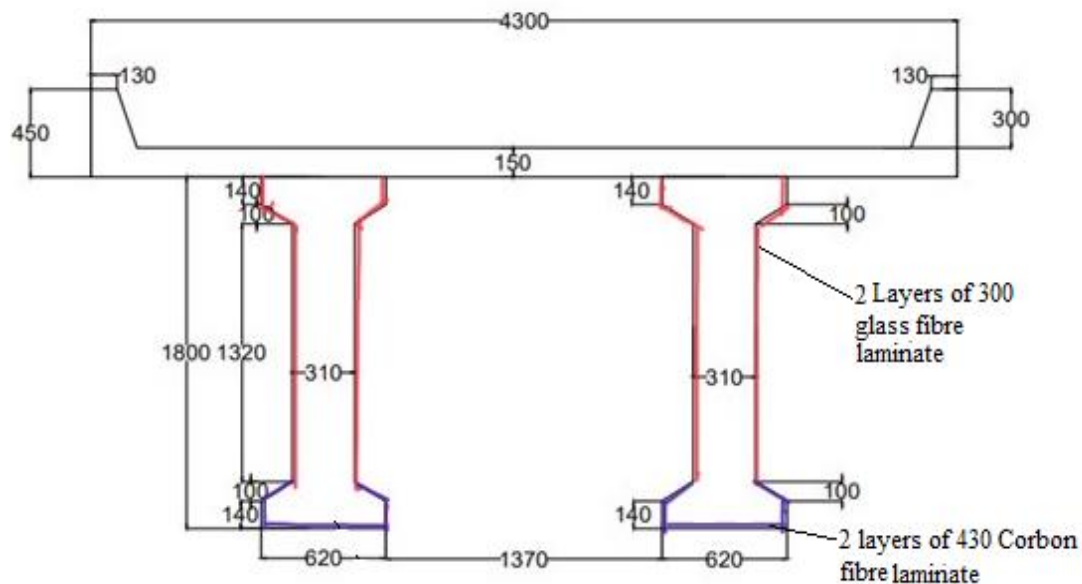
Figure 5. 54 Section view of strengthening plan

From the analysis done in section 3.6 of chapter 3 and section 5.3 of this chapter no 5, it is concluded that if the girder size is larger than 15 meters then the three-layer carbon and fibre wrapping will be needed. At the same time, if the girder size is equal to or smaller than 15 meter then the double layer carbon wrapping in flexure and double layer of glass fibre polymer should be sufficient. So as per the recommendation, the bridge girder is retrofitted accordingly with 2 layer of glass fibre is in the shear zone and two-layer of carbon fibre in the tension zone. As shown in figure 5.54 figure 5.55 and the site image is in figure 5.56.

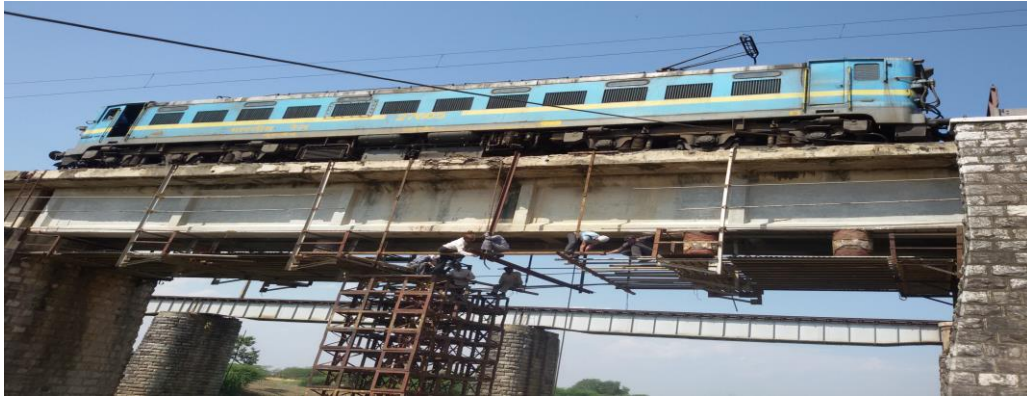
**Figure 5. 57** Load applied on the bridge using wagon 7 and sensors at site

After strengthening, the WAGON – 7 rail engine of Indian Railways was made to run over the bridge to record the deflections and frequencies in the static and dynamic loading conditions at different speeds (Figure 5.57). The details of WAGON 7 are listed in table 2 below:
