Tribological Behaviour Under Freezing Environment

5.1. Introduction

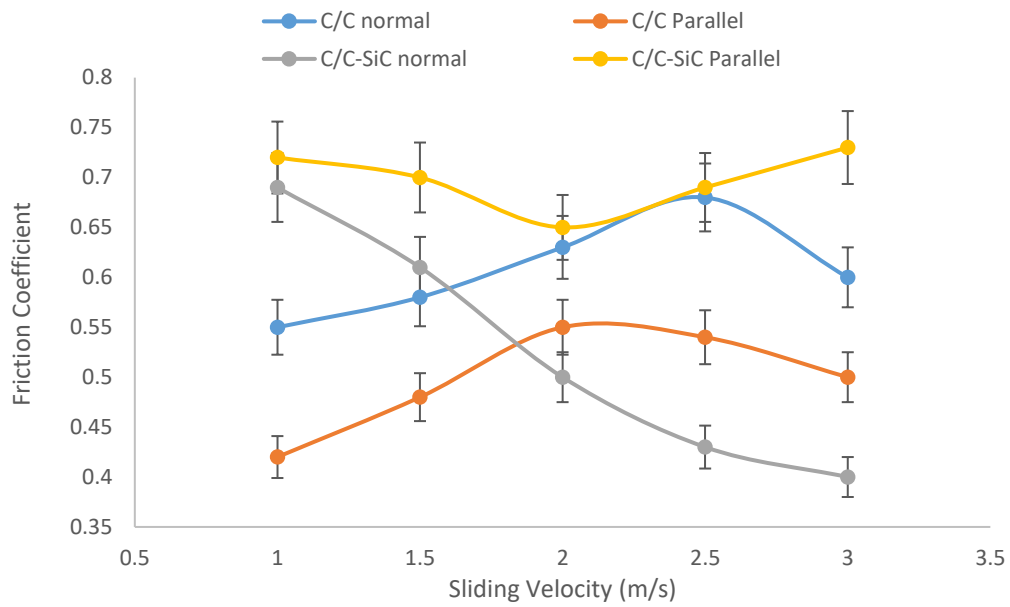
Fig. 5.2 shows the variation of friction coefficient with sliding velocity. It can be observed that friction coefficient of C/C composites for both parallel and normal orientation of laminates first increased with increase in sliding velocity and decreased afterwards. However, C/C-SiC normal showed decrease in friction coefficient with increase in sliding velocity and C/C-SiC parallel showed decrease up to 2 m/s sliding velocity and increase afterwards.

Fig. 5.2. Variation of friction coefficient with sliding velocity for C/C normal, C/C parallel, C/C-SiC normal and C/C-SiC parallel.

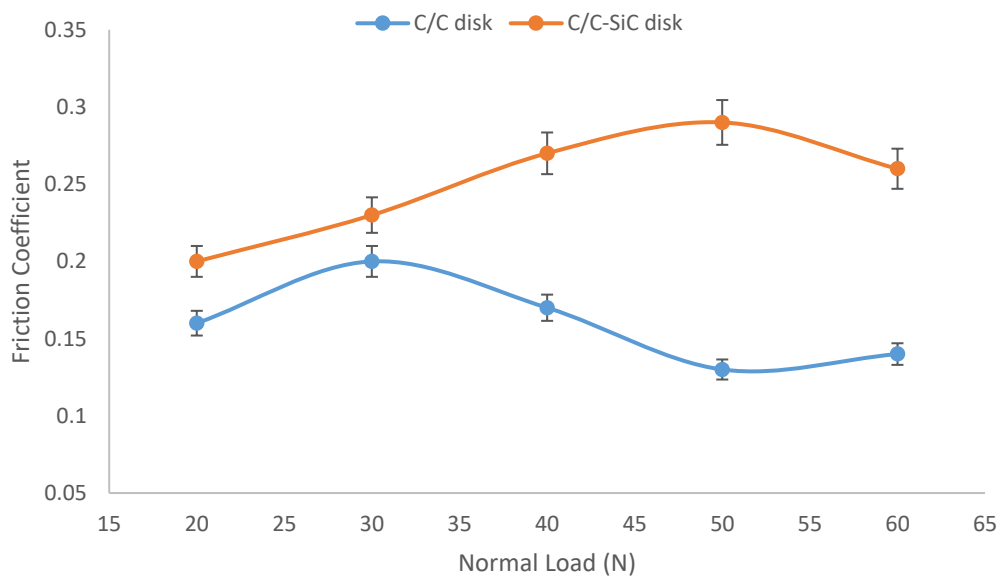
Fig. 5.3. Variation of friction coefficient with normal load in non-conformal hertzian contacts for C/C and C/C-SiC disks.

The friction coefficient of C/C composites in case of non-conformal hertzian contacts first increased up to 30 N load and decreased afterwards with increase in load as can be observed in Fig. 5.3. The value of friction coefficient of C/C-SiC plate first increased with load up to 50 N load and decreased at 60 N load. It can also be observed that value of friction coefficient in case of non-conformal hertzian contacts was lower as compared to low conformity contacts.

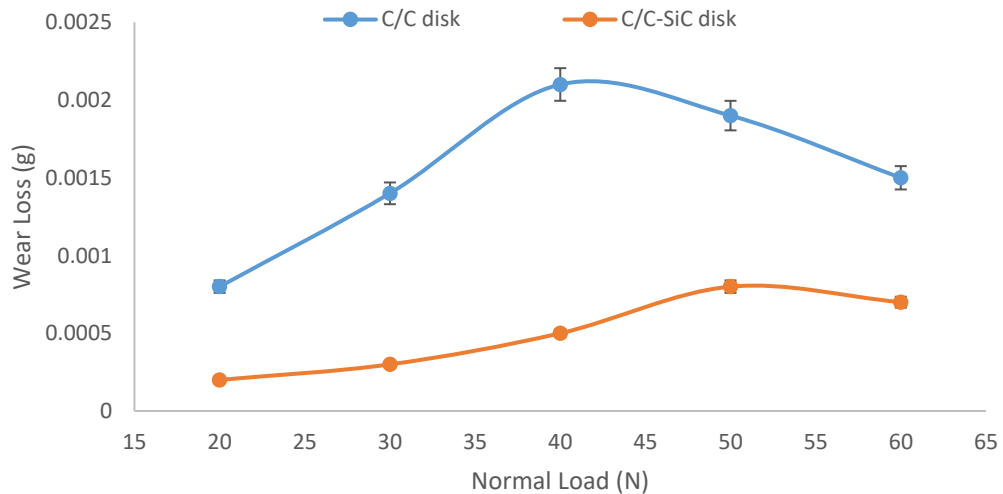
Fig. 5.7. Variation of wear loss with load for non-conformal hertzian contacts for C/C and C/C-SiC disks.

In case of non-conformal hertzian contacts, C/C and C/C-SiC composites showed almost same wear behaviour i.e. initial rise with increase in load and then decrease, and initial dip with increase in sliding velocity and increase afterwards.

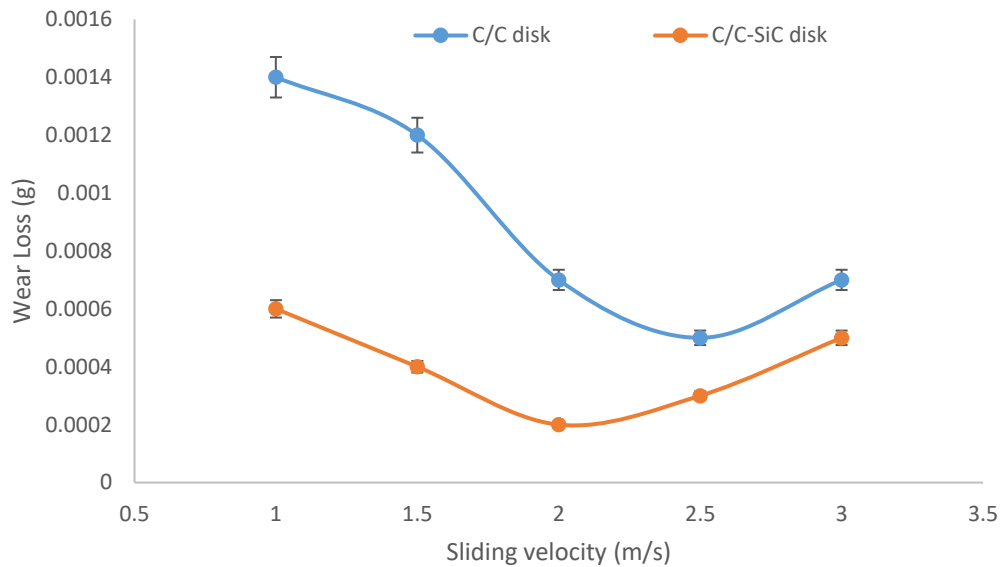
Fig. 5.8. Variation of wear loss with sliding velocity for non-conformal hertzian contacts for C/C and C/C-SiC disks.

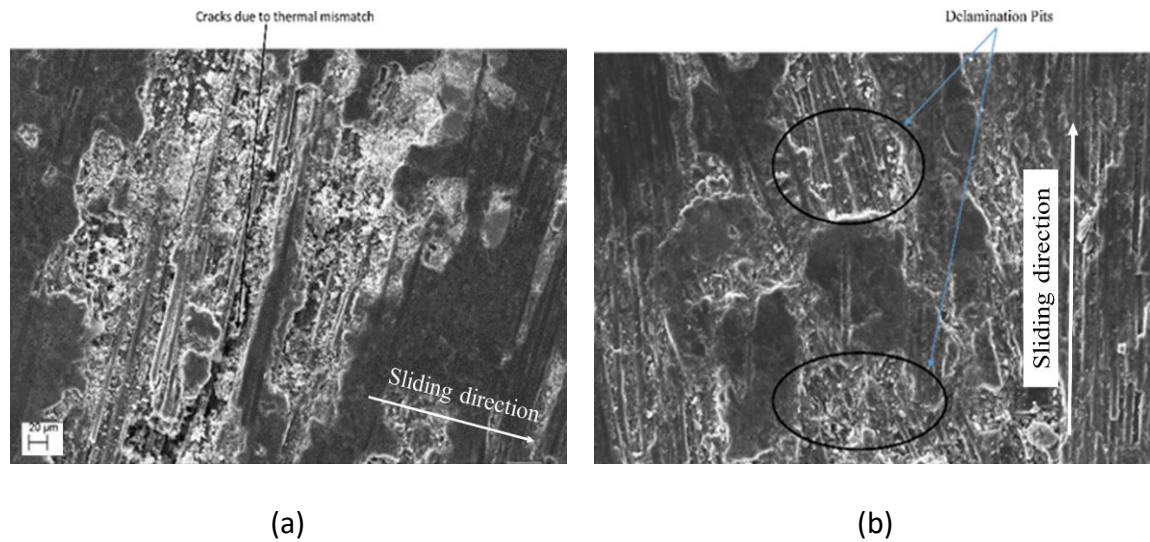
Due to thermal mismatch between fibre and matrix, cracks were developed as composites were kept in freezing environment. This effect was predominant in case of parallel orientation of laminates as parallel laminated composites contained more proportion of fibres at contacting surface. Due to development of cracks in case of C/C composites, carbon matrix loosened and its emergence as wear debris was easy when the load was applied. Thus the wear loss in case of C/C parallel was more as compared to C/C normal at 20 N and 30 N. Fig. 5.18(a) shows C/C parallel tested at 30 N load. Cracks due to thermal mismatch can be observed. Wear loss in case of parallel orientation of laminates increased up to 30 N load due to desorption of water molecules and loosening of carbon matrix. However as the load was increased from 30 N to 50 N, wear loss decreased due to formation of smooth surface due to filling up of porous sites on the surface and formation of friction film. However as the load beyond 50 N, early formation of friction film took place. After the formation of friction film, debris generation was less. Due to repeated stress and increase in temperature, friction film delamination occurred (as illustrated in Fig. 3.3 (b)) and it required more debris to be compacted to form continuous friction film. This led to increase in wear loss at 60 N load. Fig. 5.18(b) shows C/C parallel tested at 60 N load. Delamination pits can be observed in Fig. 5.18(b).

Fig. 5.18. SEM images showing (a) Cracks due to thermal mismatch in C/C parallel tested at 30 N, and (b) Delamination pits in C/C parallel tested at 60 N.

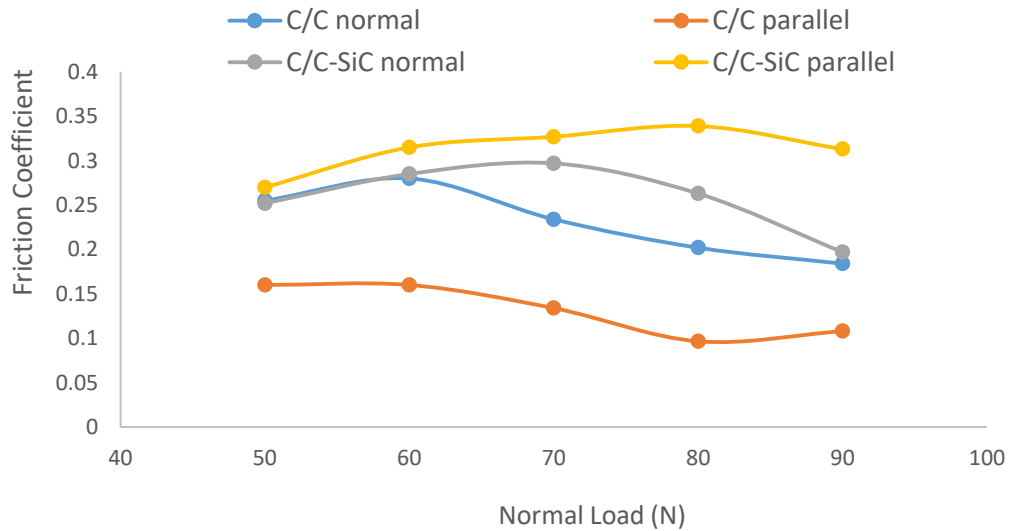
It can be observed from Fig. 5.19 that in case of reciprocating sliding conditions, friction coefficient of C/C normal firstly increased with increase in normal load up to 60 N and

decreased thereafter. The friction behaviour of C/C parallel was almost same as that of C/C normal. C/C-SiC composites also showed first rise in friction coefficient with increase in load and decrease afterwards.

Fig. 5.19. Variation of friction coefficient with normal load in low conformity contacts for C/C normal, C/C parallel, C/C-SiC normal and C/C-SiC parallel.

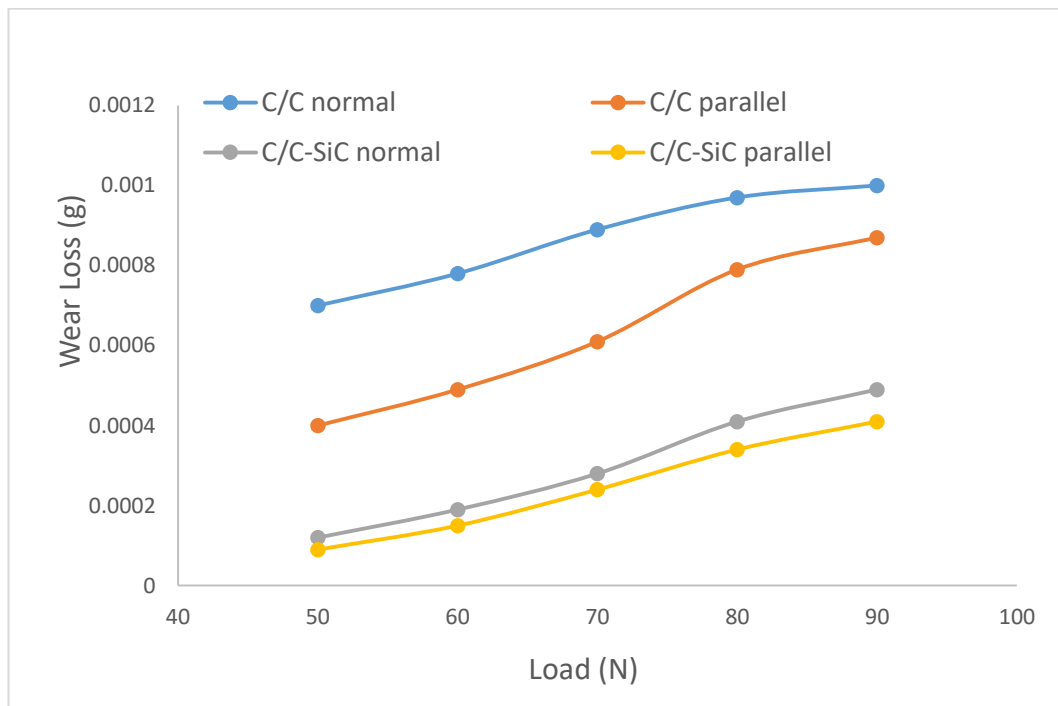
C/C and C/C-SiC composites showed increase in wear loss with increase in load for low conformity contacts as can be observed in Fig. 5.21. The wear loss in case of non-conformal hertzian contacts firstly increased with increase in load and decreased thereafter for both C/C and C/C-SiC composites Fig. 5.22.

Fig. 5.21. Variation of friction coefficient with load in low conformity contacts for C/C normal, C/C parallel, C/C-SiC normal and C/C-SiC parallel composites.

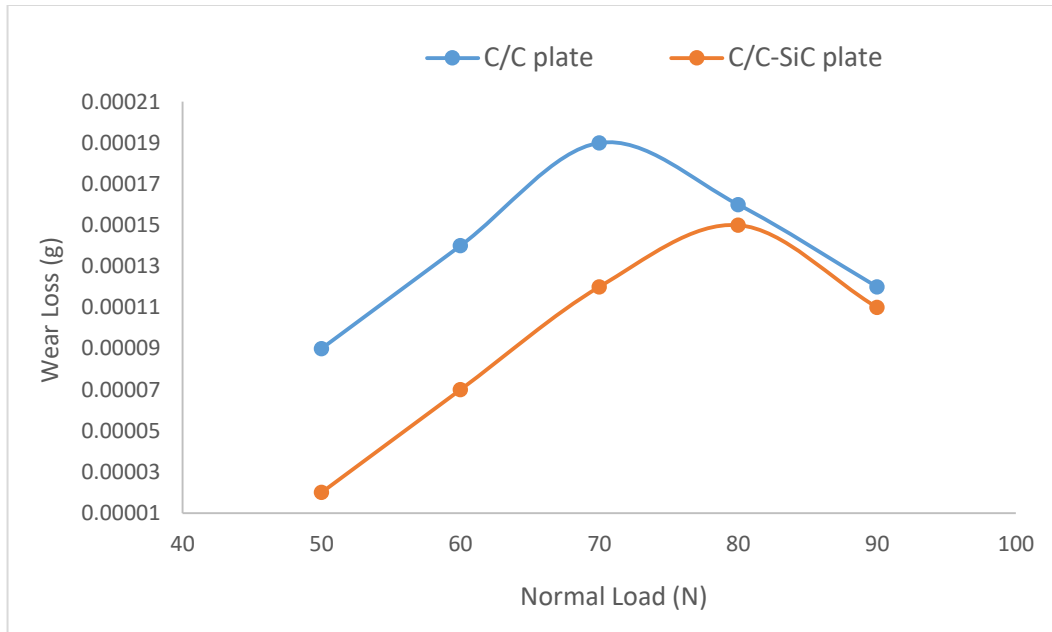
Fig. 5.22. Variation of friction coefficient with load in non-conformal Hertzian conformity contacts for C/C and C/C-SiC plates.

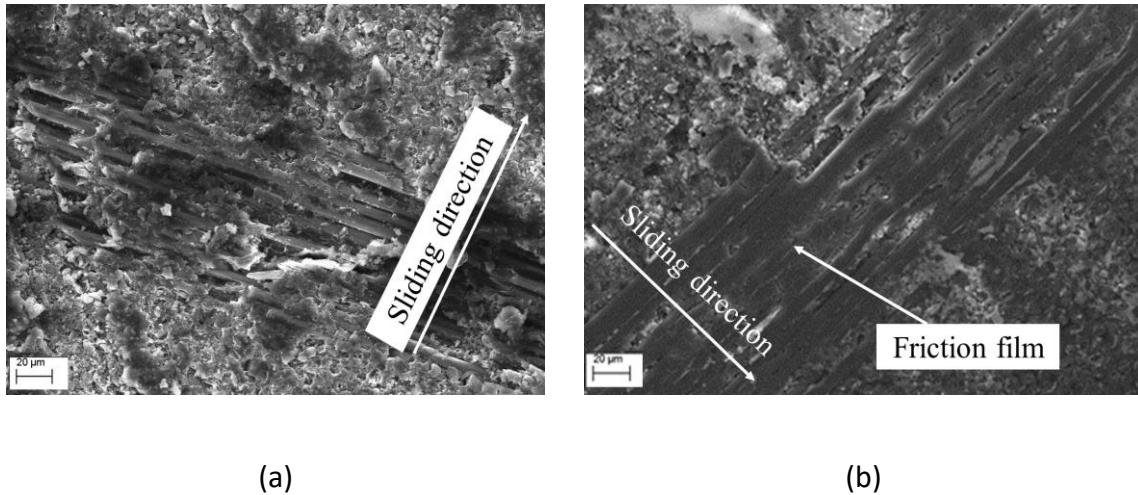
In case of reciprocating motion, sliding occurs in a very confined region. So the wear debris is not usually ejected out from the contact surfaces. Friction coefficient of C/C normal increased with increase in load up to 60 N. This may be attributed to the deeper penetration of asperities. Repeated flexion in opposite direction resulted in the generation of bending stresses due to which cracks initiated and have a tendency to propagate parallel to the lamina. The loosened matrix material due to initiation of cracks rolled in between the contact surfaces. At higher loads, easy pulverization and shearing of wear debris formed a friction film on the surface which led to decrease in friction coefficient. Fig. 5.23(a) and Fig. 5.23(b) show C/C normal tested at 60 N and 70 N load respectively. It can be seen that friction film was observed at 70 load but there were negligible signs of friction film at 60 N load. When

C/C normal was tested in dry conditions at 60 N load, friction film started to form but in case of freezing conditions, first signs of friction film were observed at 70 N load.

Fig. 5.23. SEM images showing C/C normal tested at (a) 60 N load, and (b) 70 N load.
