# Retrofitting and Rehabilitation of damage footbridge over Yamuna River

Anjani Kumar Shukla, P R Maiti

**Abstract:** Every Structure has a certain predefined age with which it has to withstand, and after that, it requires the rehabilitation/repairing to avoid any damage or collapse. The footbridge over Yamuna River in Delhi, India was constructed in 1960 adjacent to Wazirabad barrage, and this is a very important link to East Delhi and West Delhi. Due to heavy traffic plying on this footbridge, in due course of time, the signs of deterioration were visible in the bridge expansion joint assemblies in the deck slab and cantilever portion of footpath slab. There were many potholes also developed in the wearing course. It was also dilapidation observed in many portions of the footpath, and some portion of the footpath slab were collapsed. The cantilever portion of the footbridge was retrofitted with steel jacketing fixing in the main longitudinal girder of the bridge. In this study analysis of the cantilever footbridge slab retrofitted by a steel jacket was carried out to check the deflection and stress limit of the bridge and it is found that the bridge is safe and now Bridge is op

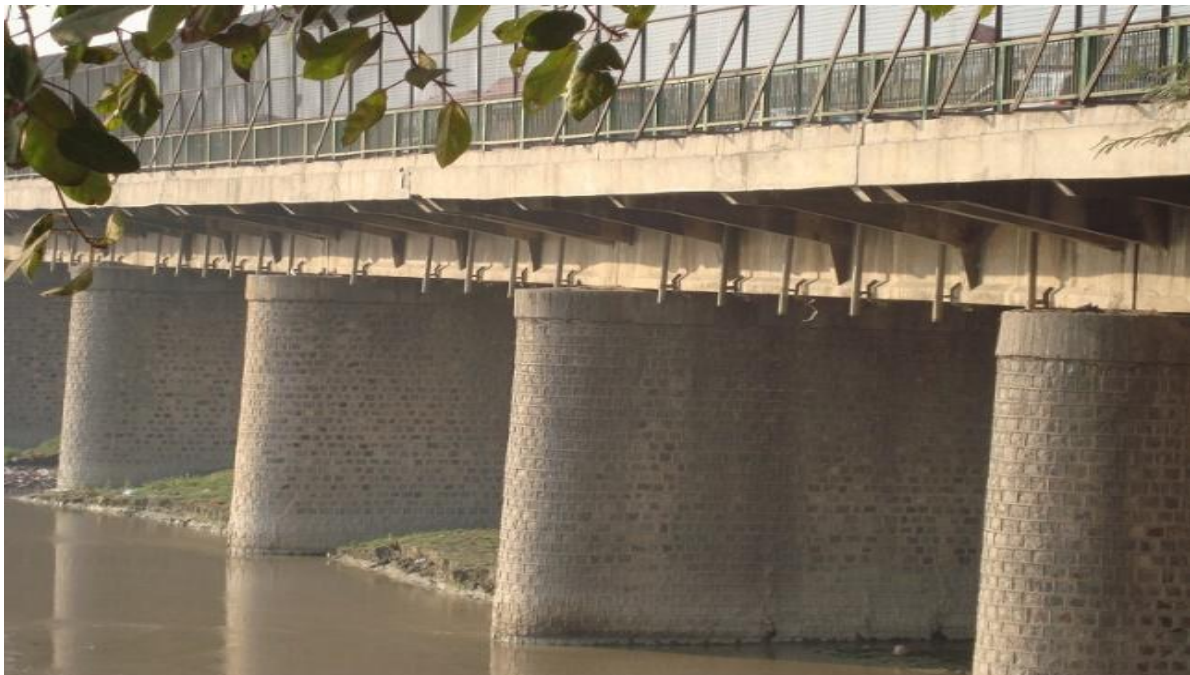
Figure 2 Global Image of Yamuna Bridge

The 23 span Bridge consisting 22 concrete piers and 2 abutments. The total length of bridge is 460 meters and total width of footbridge is 3.0 meter. It is supported on cantilever is situ cast beam. Figure 2 Present a global view of footbridge portion supported on cantilever beam. The Bridge has 2.5% Longitudinal and 0.75% of traverse slope.

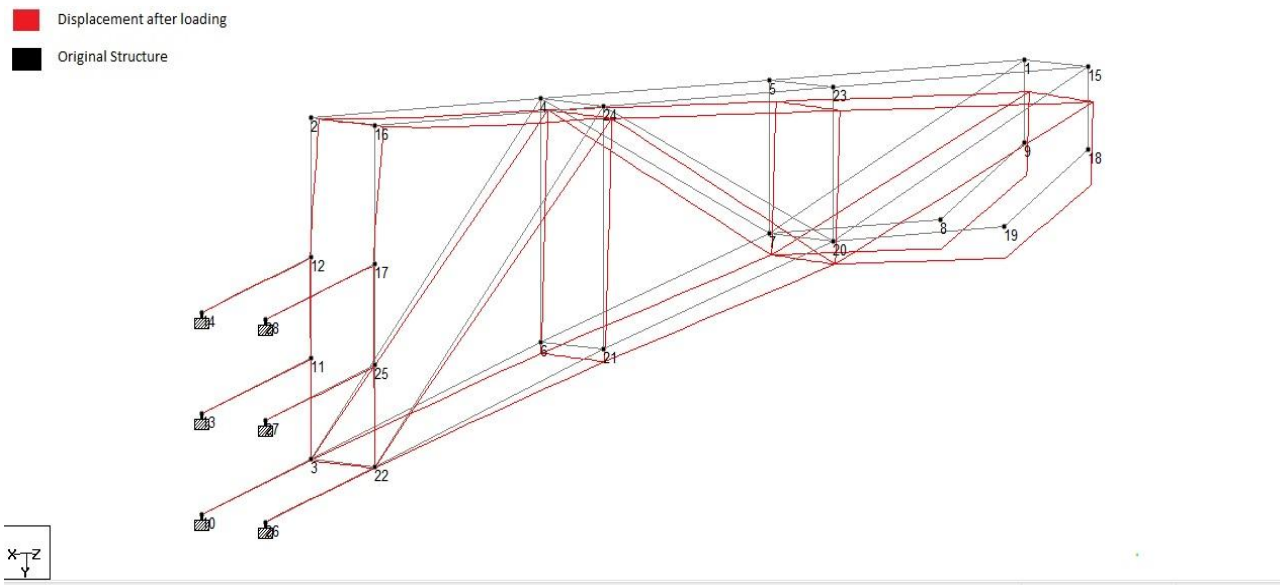
Figure 13 Deformed shape of Steel Jacketing Structures

The analysis of jacked steel structure using STAAD.Pro V8i was carried out to check whether structure is safe or not. In Figure 13 the deflected shape of steel jacking structure and Node displacement in Figure 13 is shown when it is loaded.

1. The Maximum Resultant Displacement is 9.526 mm, which is in downward side.
2. The Maximum Horizontal Displacement in X direction is 4.957 mm.
3. The Maximum Axial Compressive Stress is -9.227 N/mm<sup>2</sup> in both steel beam which is fix with main girder of bridge and between node 22-26 and 3-10.
4. The Maximum Axial Tensile Stress is 21.824 N/mm<sup>2</sup> in Both steel beam which is fix with main girder of bridge and between Node 17-28 and 12-14.
5. Retrofitted footbridge were open for the traffic (Figure 14) when analysis steel jacketing members and found all safe.
