CHAPTER 4

HIGH-TEMPERATURE SOLID PARTICLE EROSION OF TYPE 446 STAINLESS STEEL

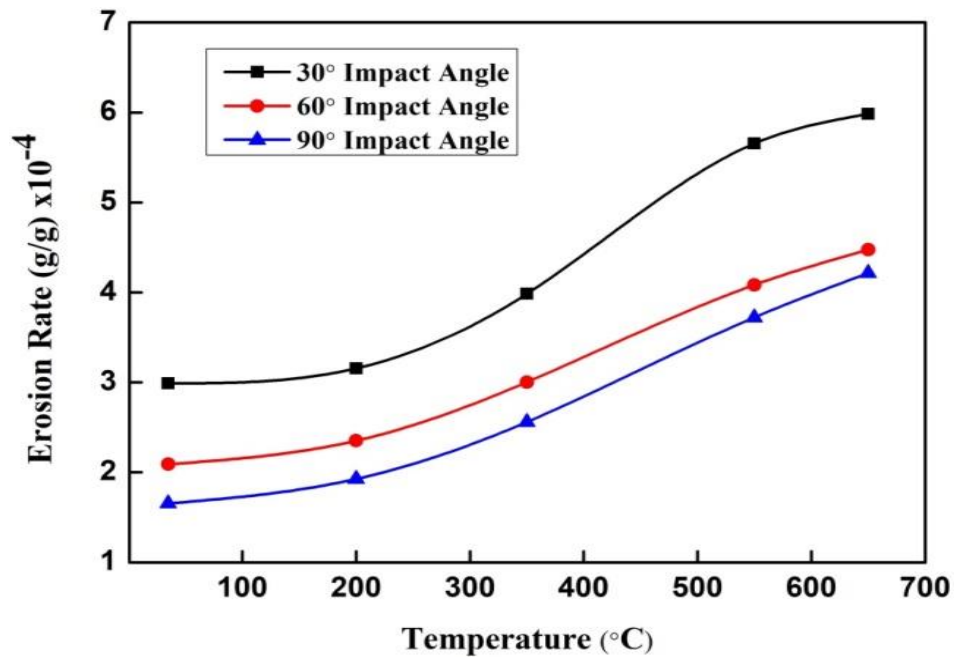
Fig. 4.1: Dependence of ER on the temperature at an impingement angle of 30°, 60° and 90°.

The temperature dependence of erosion rate on Type 446SS at the impact angle of 30°, 60°, and 90° is shown in Fig. 4.1. The curve shape under all the impact angles is closely identical, with erosion rate being maximum at 30° and minimum at a normal impact. This is typically identified as the behavior of the ductile material. Also, the effect of temperature is prevalent in the erosion of the material. It is well observed that with the increase in temperature there is certainly an increase in the erosion rate, however, this can not be thought of as linear dependency. It is well observed that with the increase in temperature there is certainly an increase in the erosion rate, however, this can not be thought of as linear dependency. It is noted that the increase in ER is less significant up

to 350°C, whereas in the range of 350°C to 550°C a steep slope is observed which is indicative of higher ER.

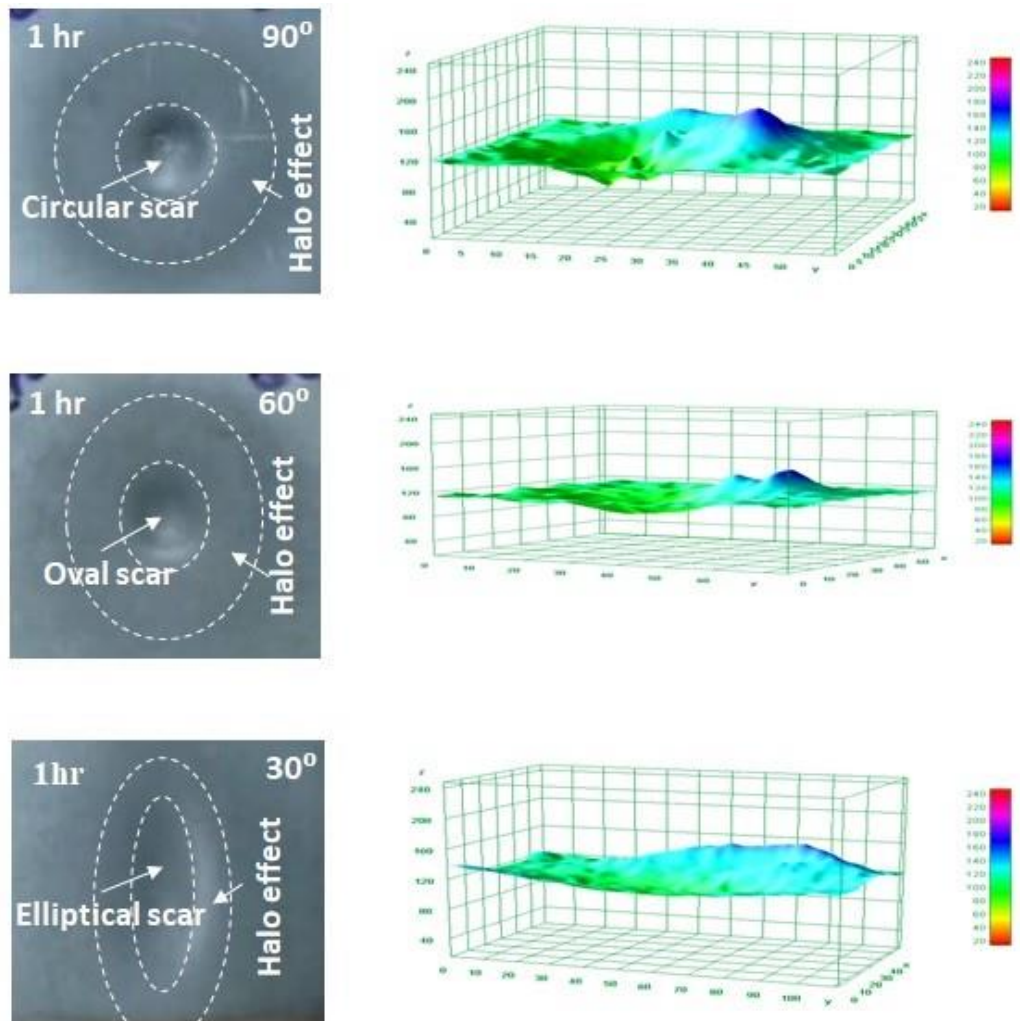
normal impact of 90° showed an approximate circular scar. The orientation of the specimen at different impact angles and divergence of the particle stream leads to the formation of different impact geometry. The plumes of the impinging particles are concentrated in the central part of the stream. At all impingements, the halo effect which is characterized by secondary erosion damage is seen.

Fig. 4.3: Wear scar and 3D interactive plot of the tested material

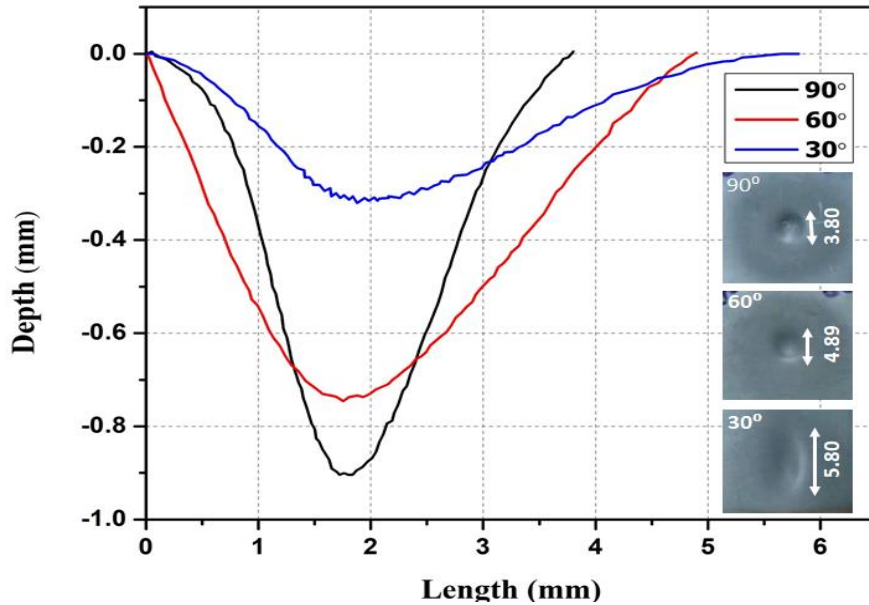
The depth of scar formed at each impact angle under each tested condition is measured using (Mitutoyo) surface roughness tester. Along with, depth profile and contour of tested samples at 30° , 60° , and 90° is shown in Fig 4.4.

Fig. 4.4: Erosion scar profile comparison for 30°, 60° and 90° angle of incidence after 1hr test at 650°C.

The erosion rate at oblique impact is maximum, but the average surface roughness (R_a) is maximum in case of the normal impact shown in Table 4.1. This is likely to happen since the normal impact created many pits on the surface, thereby squeezing the material forming more ridges. Thus the consolidated effect of pits and ridges turnout in the form of higher surface roughness.

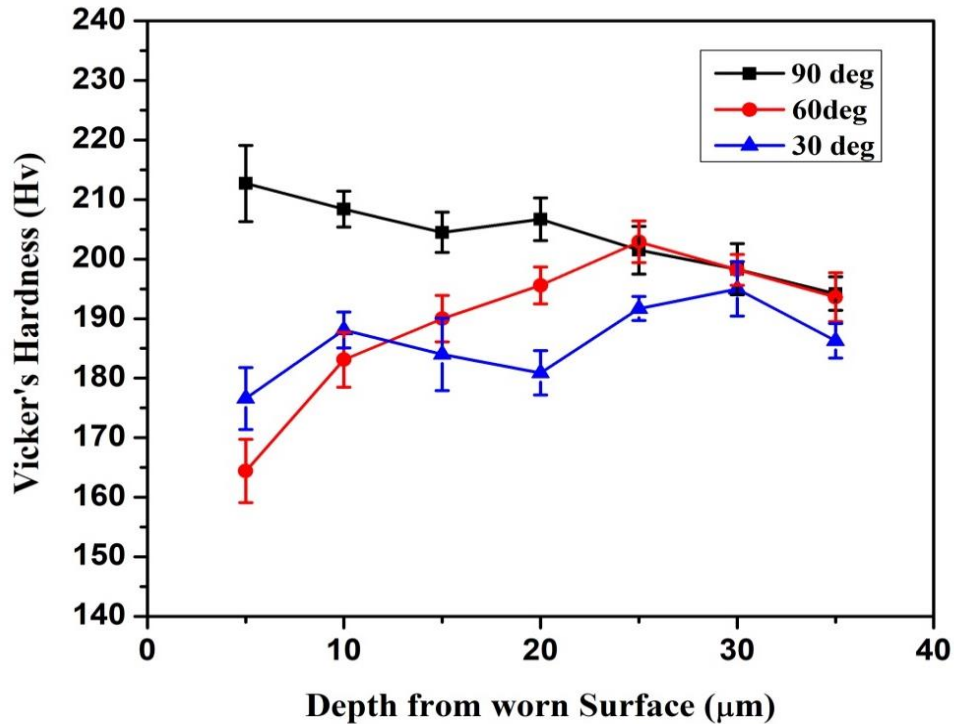
A further investigation is carried out on the sample by measuring the hardness along the cross-section beneath the scars to identify the effect of work hardening beneath the surface which suffers the repeated impact.

Fig 4.5: Hardness along the cross-section to impact surface

There is no definite trend seen in the hardness of the surface along the cross-section as clear from Fig. 4.5. However, under the normal impact, hardness increase is more significant than the oblique impact. Hardness in each case approaches the hardness of as-received conditions, i.e., 193 HV with the advancement in depth. This signifies that the impact of particle created work hardening effect to depth off ~ 30 μm below the surface. The topography of the worn-out sample is shown in Fig. 4.6.

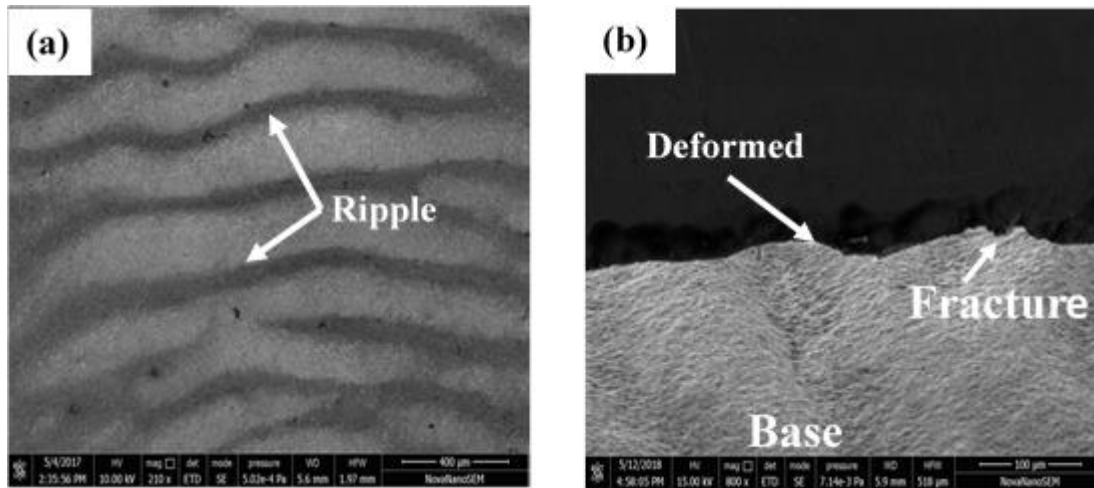
Cross-Sectional observation of Type 446SS undergone oblique impact is shown in Fig. 4.10(a-b). SEM micrograph reveals that the crests of the ripples are cut by impacting abrasives. The formation of ripples on the wearing surface is perpendicular to the direction of the velocity vector under the effect of abrasive particle impact causing plastic deformation directed along the velocity vector. The geometry of the ripples is dependent on velocity and fraction of the abrasives. Although, this ripple pattern is generally seen in oblique impacts, yet they are seen with lost coherency in normal impact conditions too. The wavelength of the protrusion formed on the crests of the ripple was approximately 180 μm. It is also seen that elevated temperature tests increased the wavelength of the ripples thereby indicating the direct dependence on temperature.

Fig 4.10: (a) SEM micrograph of eroded scar at 30° and (b) cross-section profile of the near surface of 446SS at 650°C and 30° impingement angle.
